Location:
Addison Town Hall
Addison, Maine

Photo Taken by:
Keith R Brown, P.E.

Date:
Nov. 13, 2014

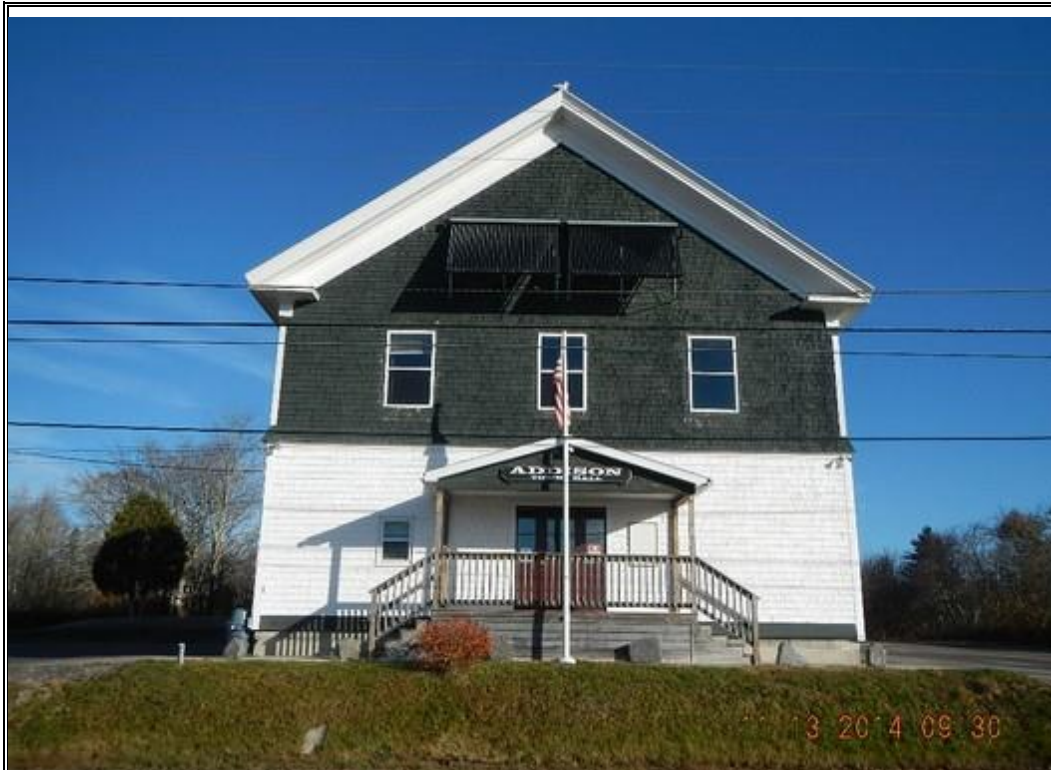
Photo Number
1

Description:
Front exterior

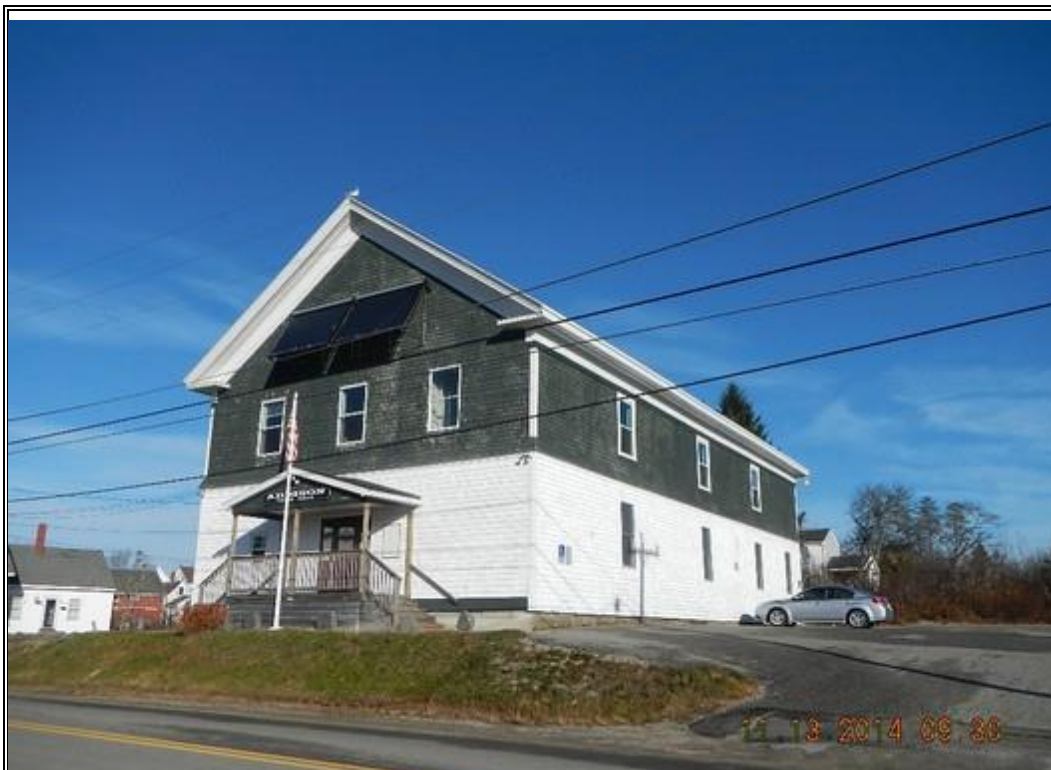
Photo Number
2

Description:
Front and right
side exterior

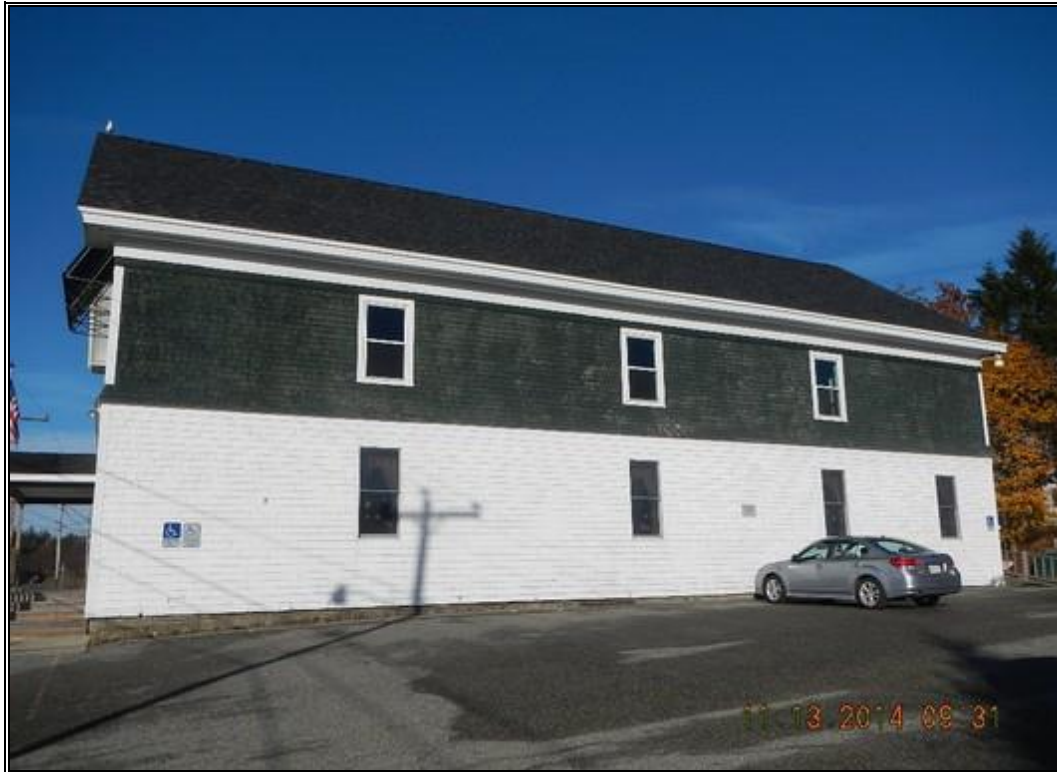
Photo Number
3

Description:
Right side exterior

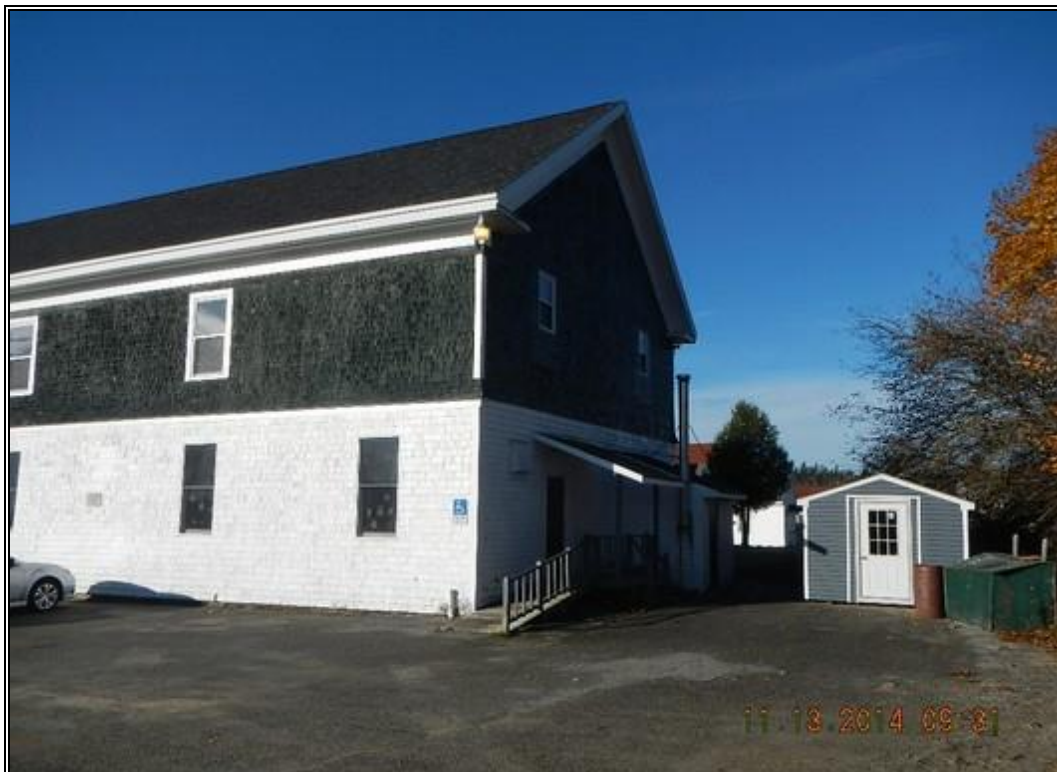
Photo Number
4

Description:
Back exterior

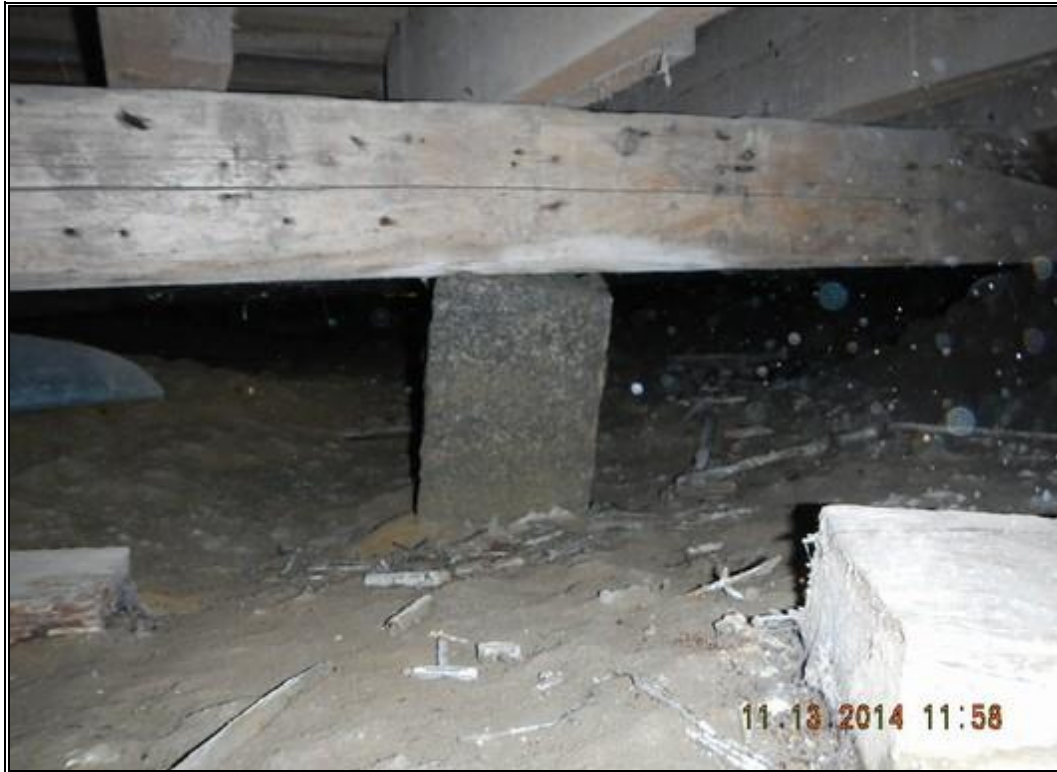
Photo Number
5

Description:
Granite floor
support pier

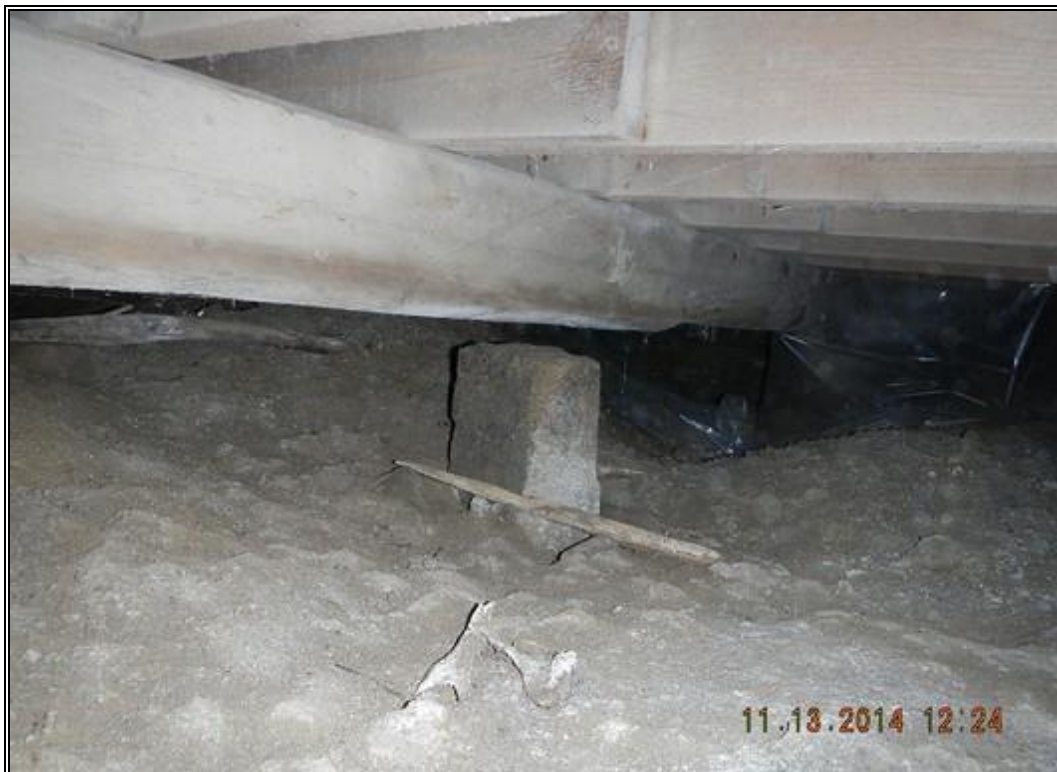
Photo Number
6

Description:
Granite floor
support pier, no
longer in contact
with timber floor
framing

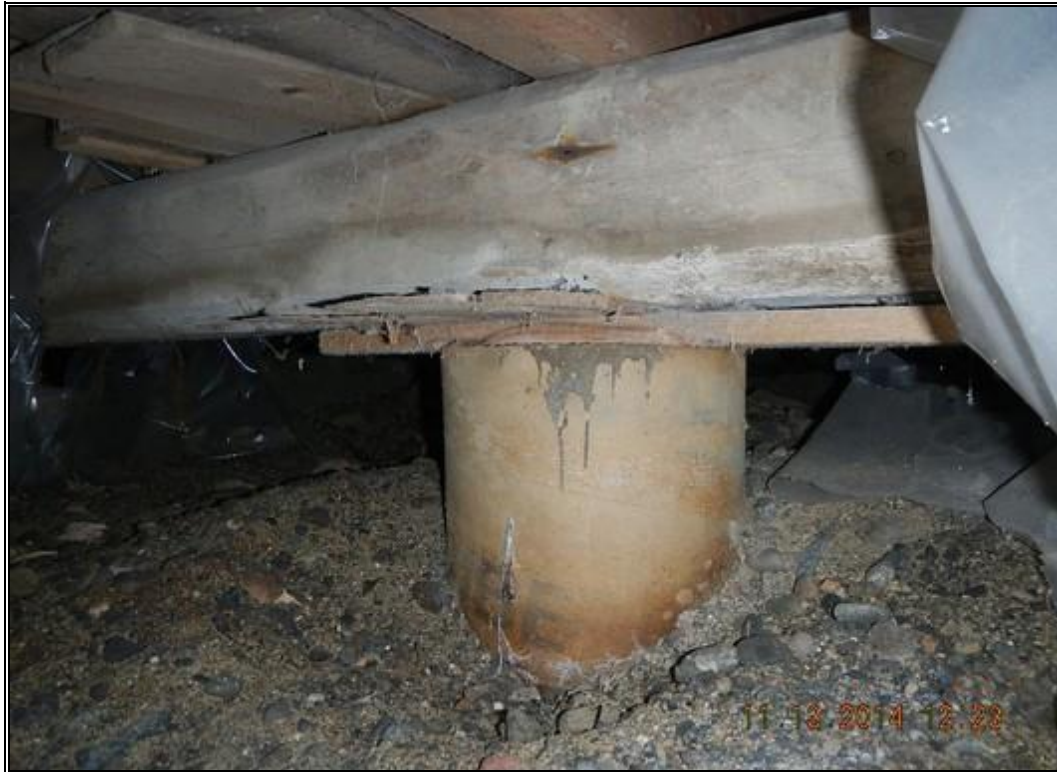
Photo Number
7

Description:
Concrete floor
support pier

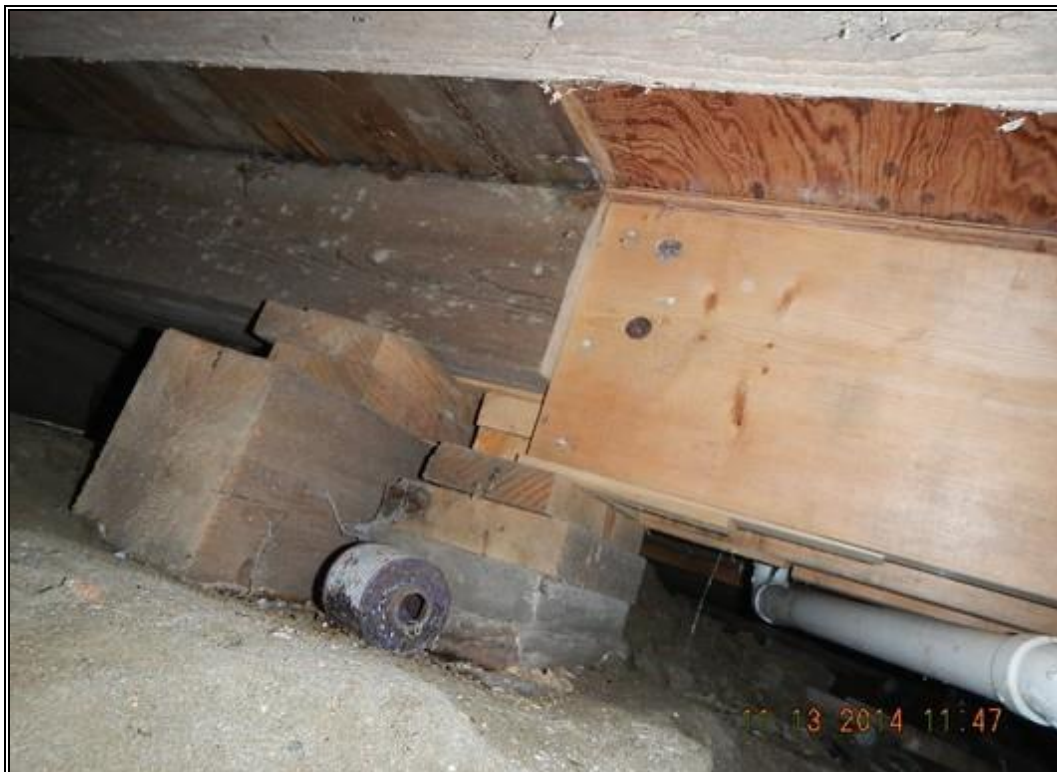
Photo Number
8

Description:
Stacked wood
blocking in contact
with dirt floor
below bathroom
area

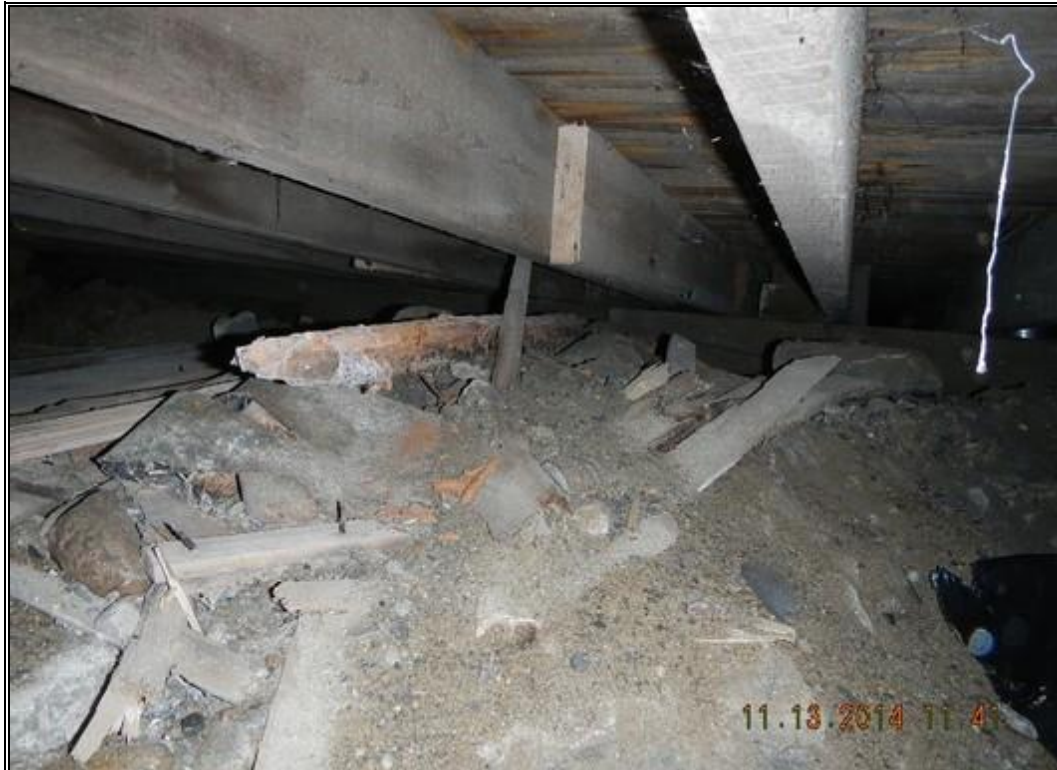
Photo Number
9

Description:
Clearance between
first floor framing
and crawl space
floor

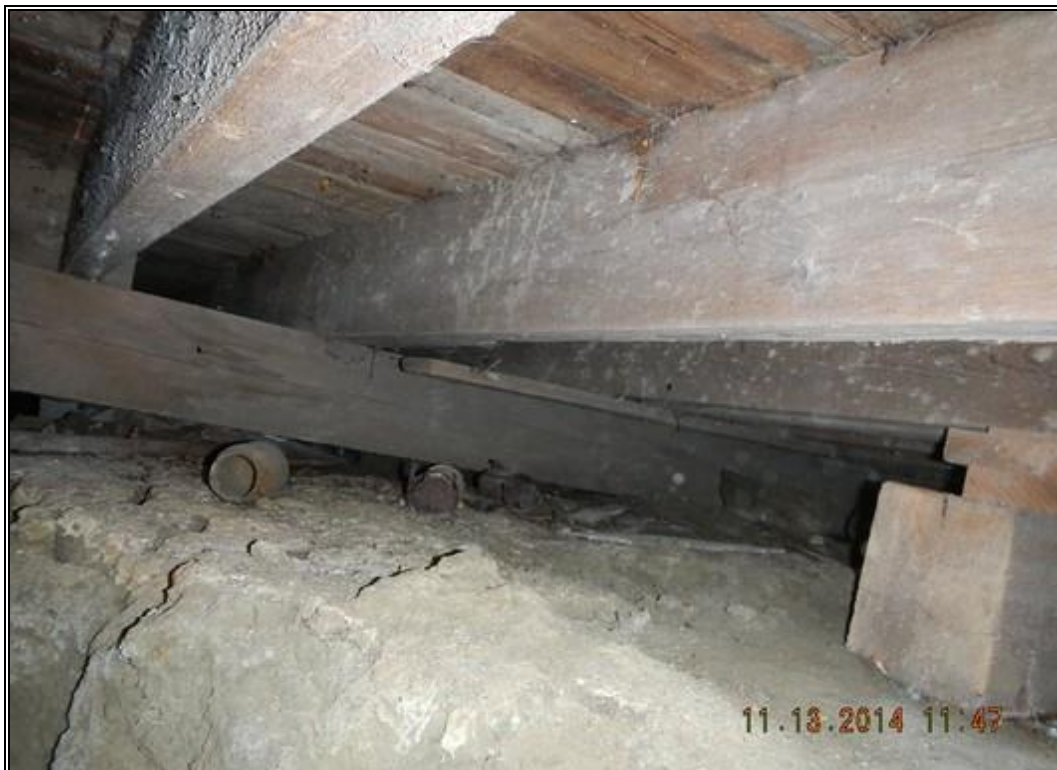
Photo Number
10

Description:
Clearance between
floor support
framing and crawl
space floor

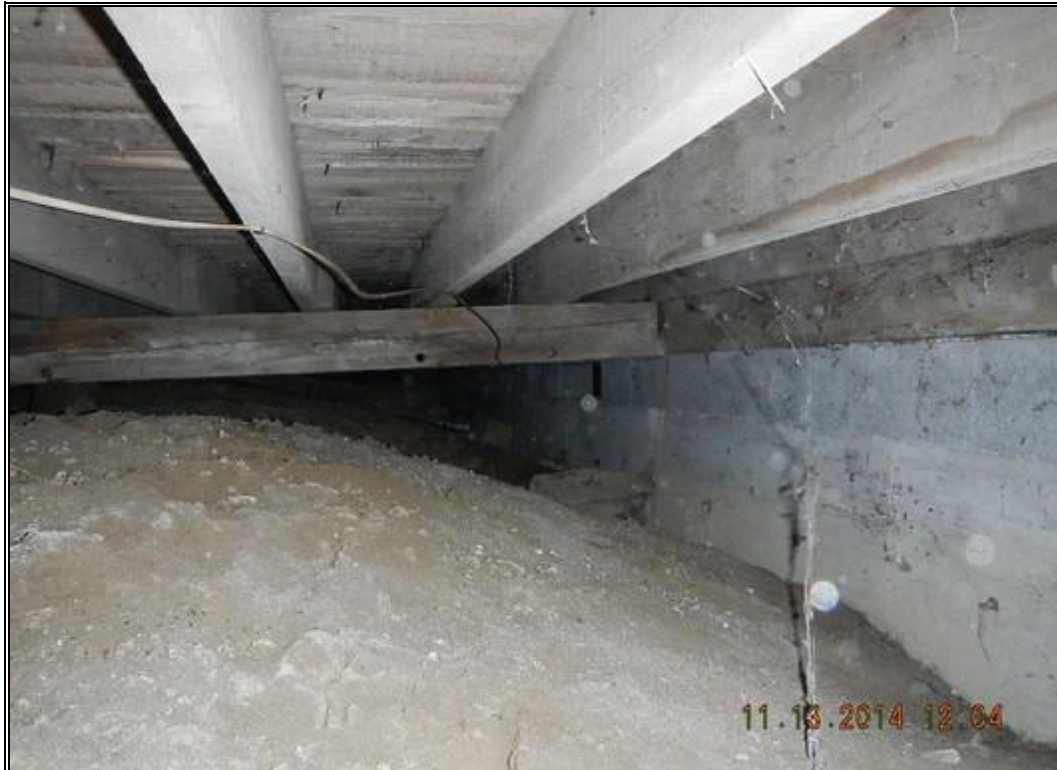
11

Description:
Clearance between
first floor framing
and crawl space
floor

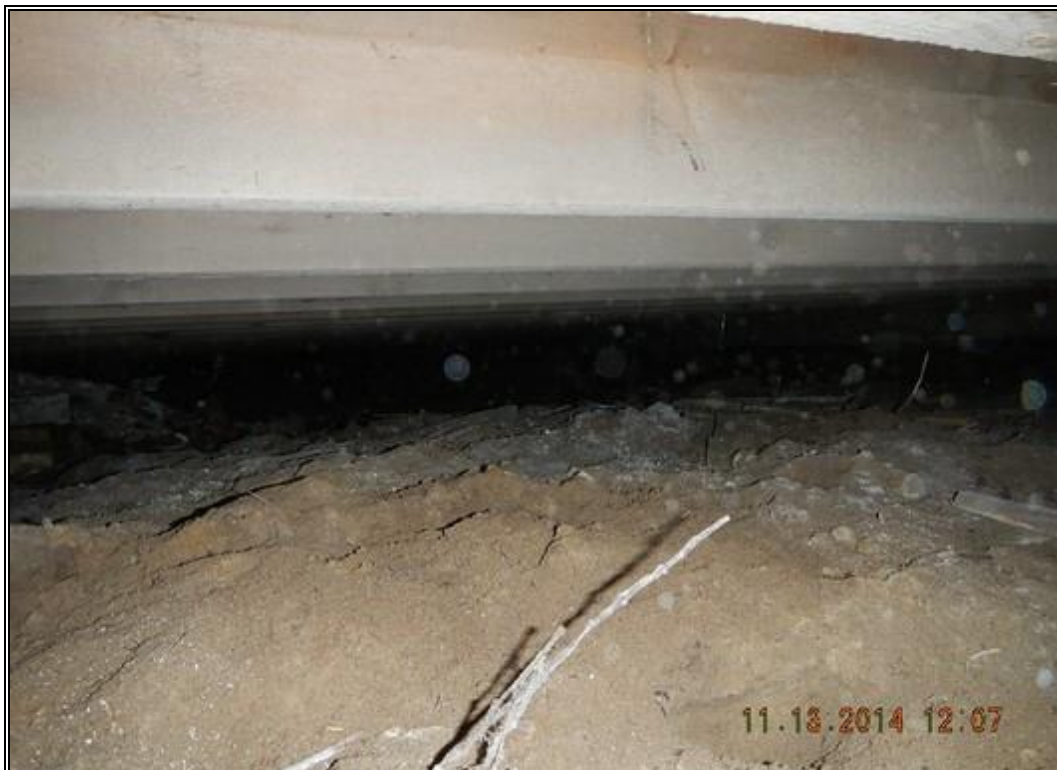
12

Description:
Clearance between
first floor framing
and crawl space
floor

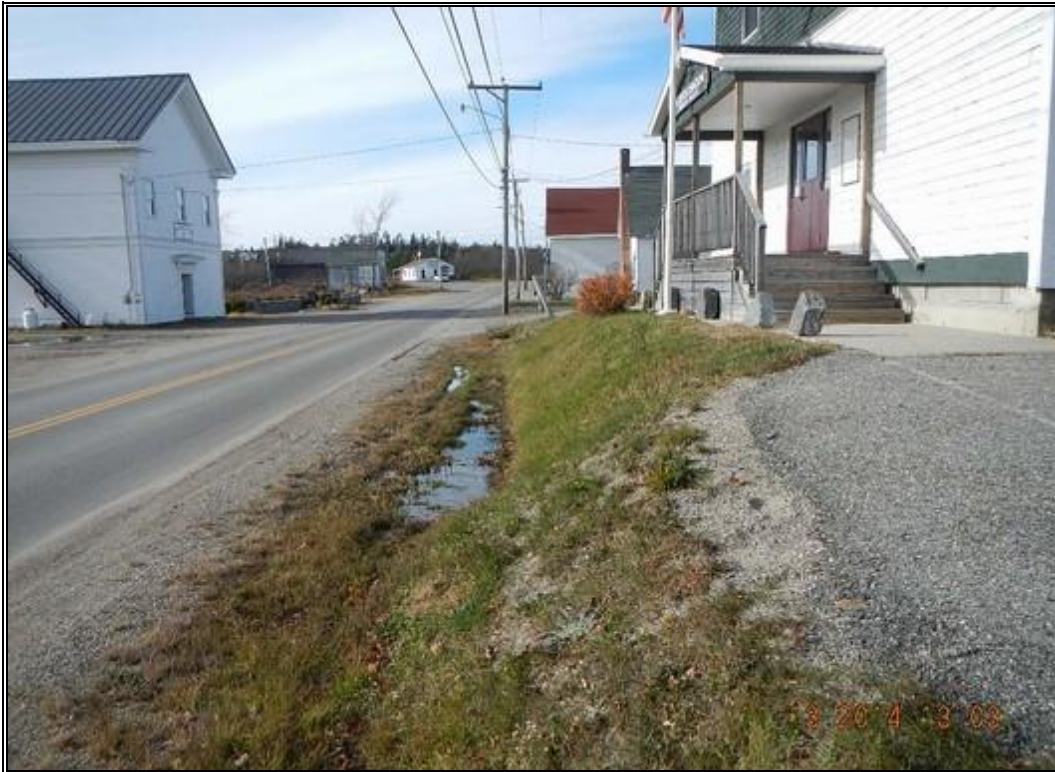
Photo Number
13

Description:
Standing water in
Water Street ditch
at front of building

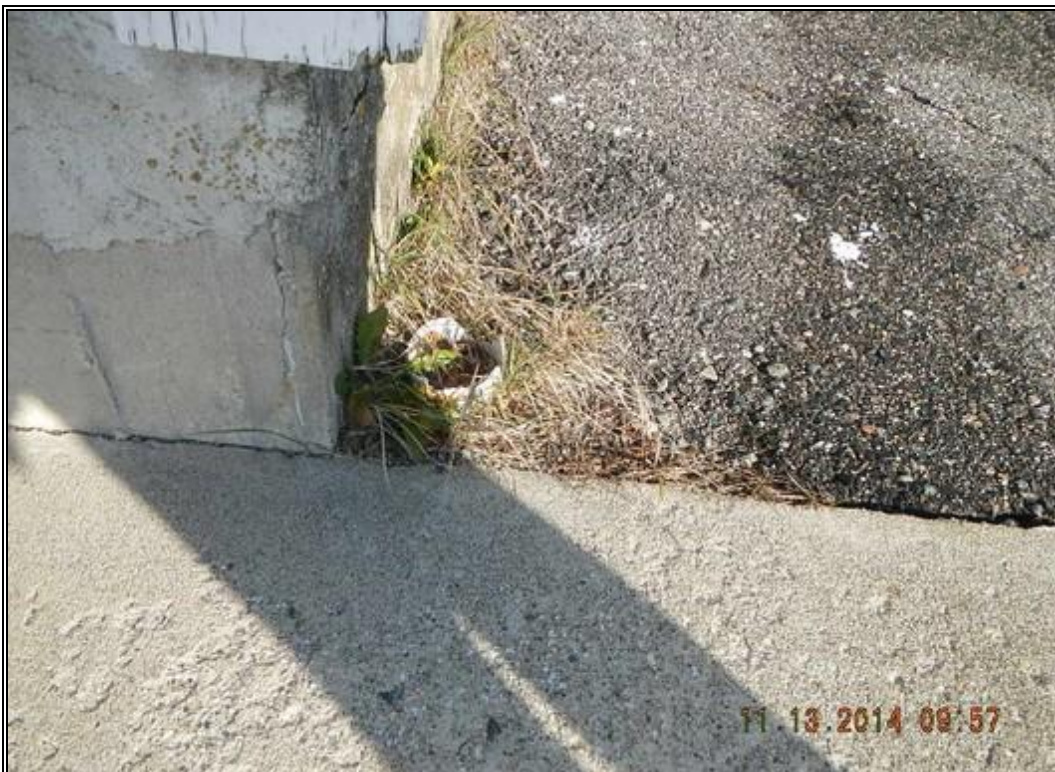
Photo Number
14

Description:
Blocked riser pipe
at exterior front
right of foundation

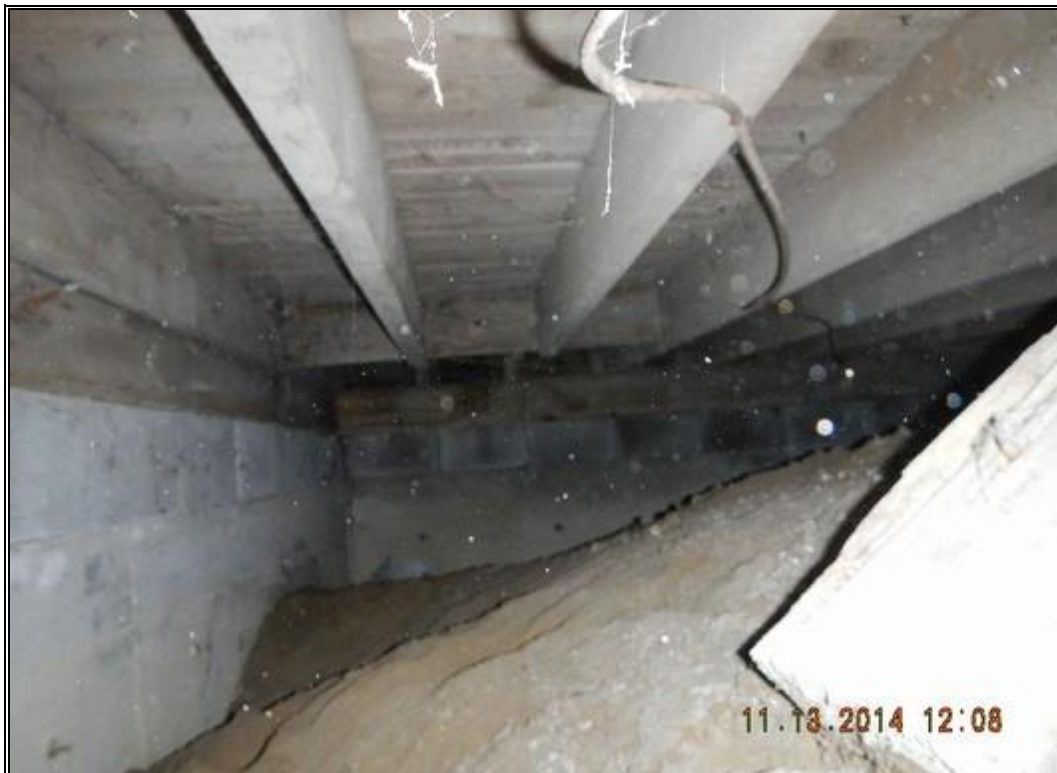
15

Description:
Single header (in background) supporting long floor joists at front left of building

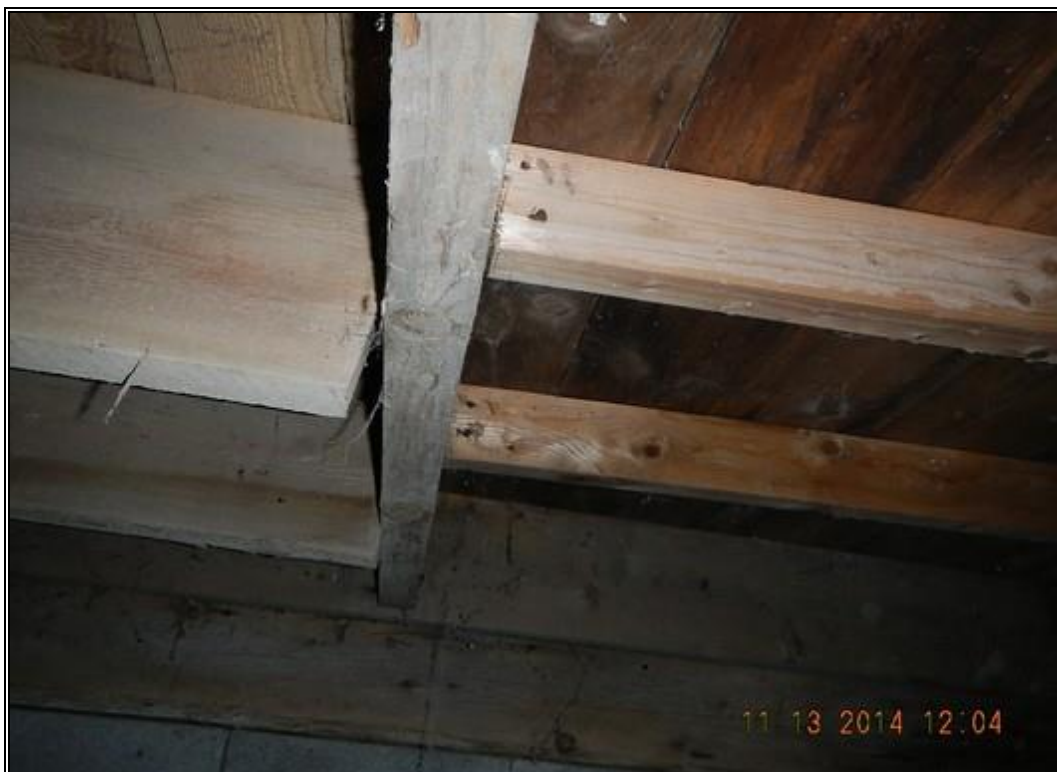
16

Description:
Light duty single joist header, original floor joists (left) and light duty floor framing (right)

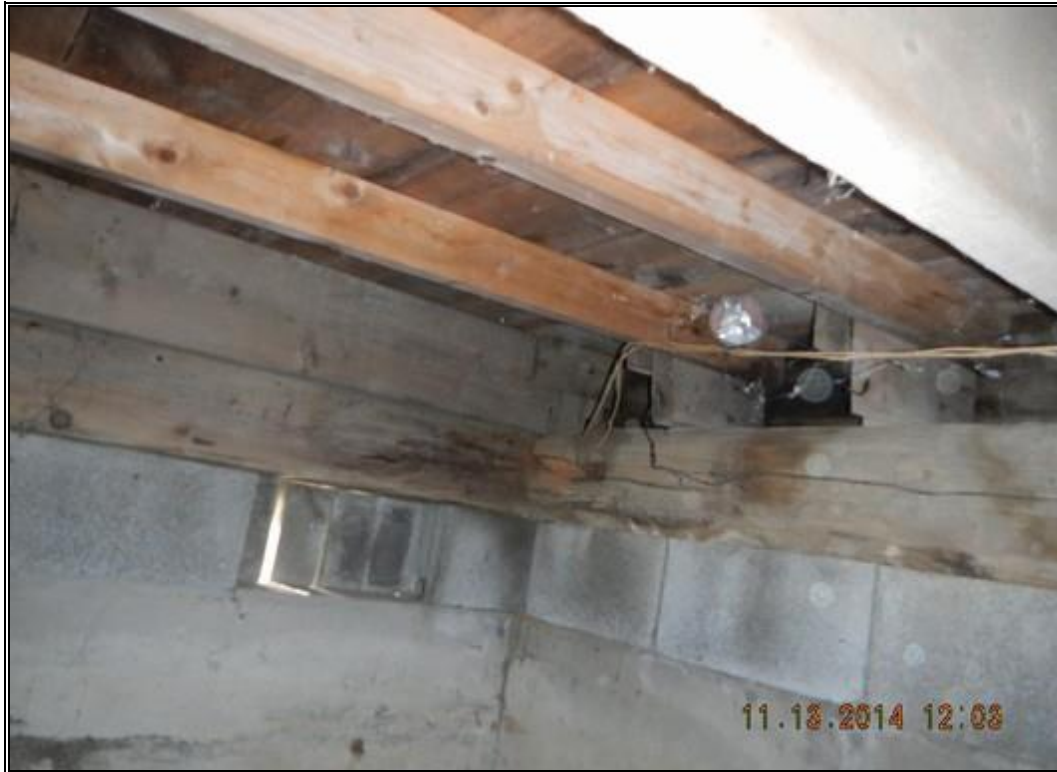
Photo Number
17

Description:
Light duty floor
framing at front
left of crawl space

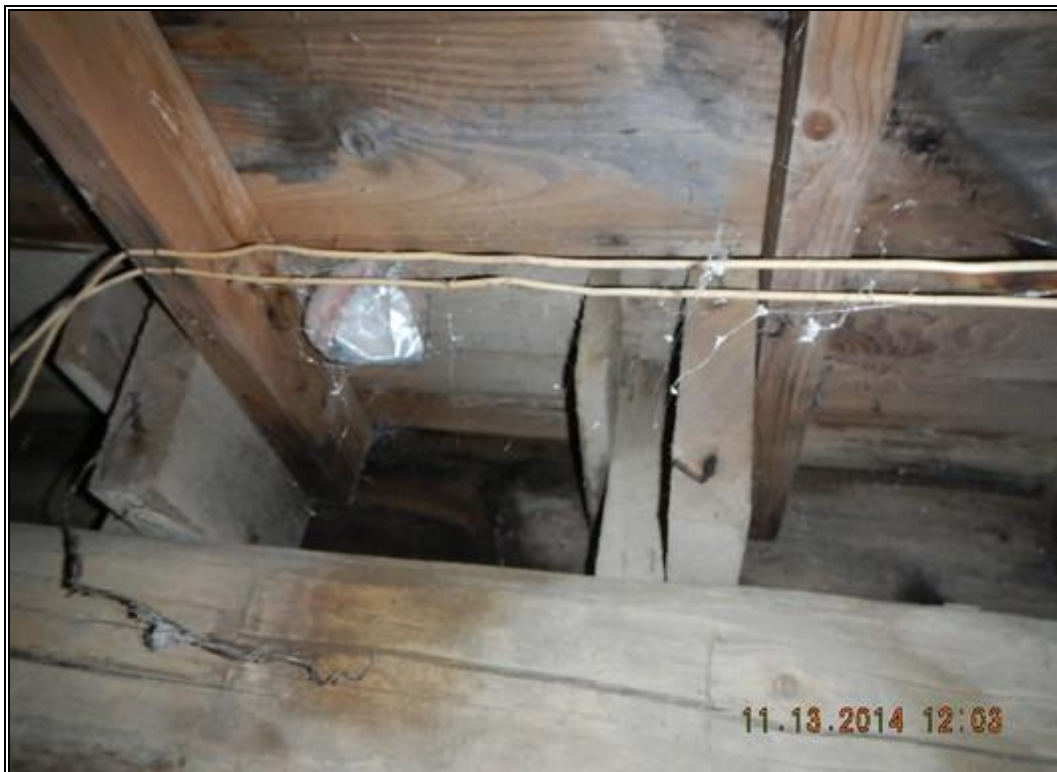
Photo Number
18

Description:
Light duty floor
framing at front
left of crawl space

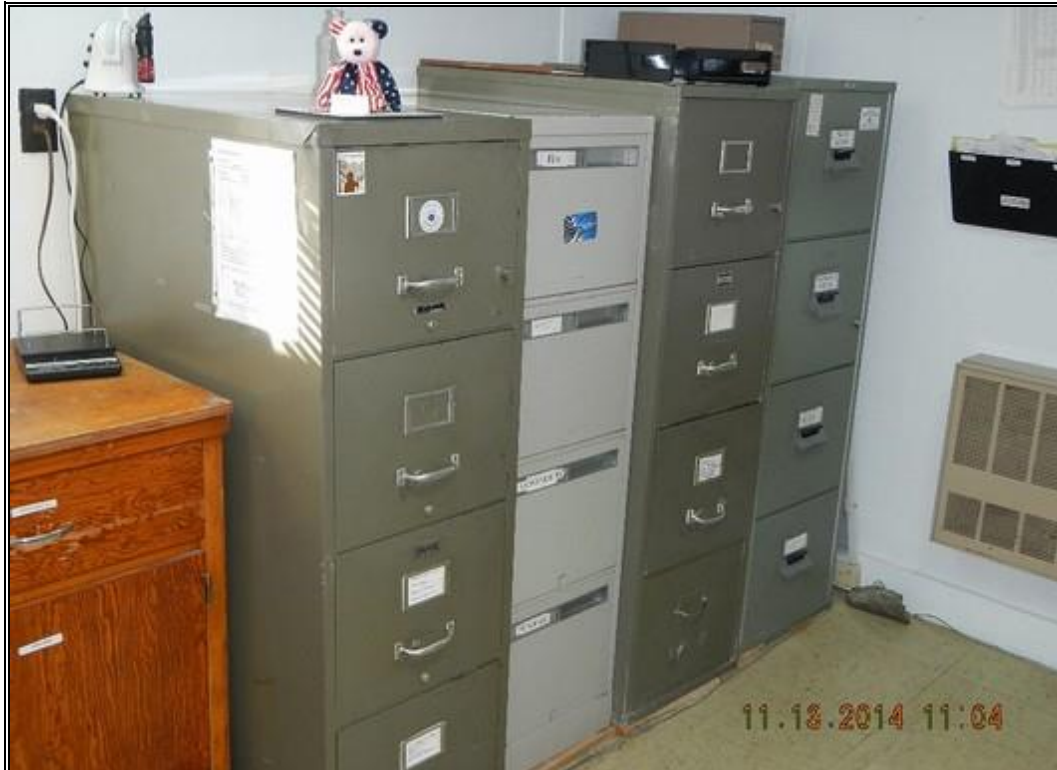
Photo Number
19

Description:
File cabinets at
front left of
building

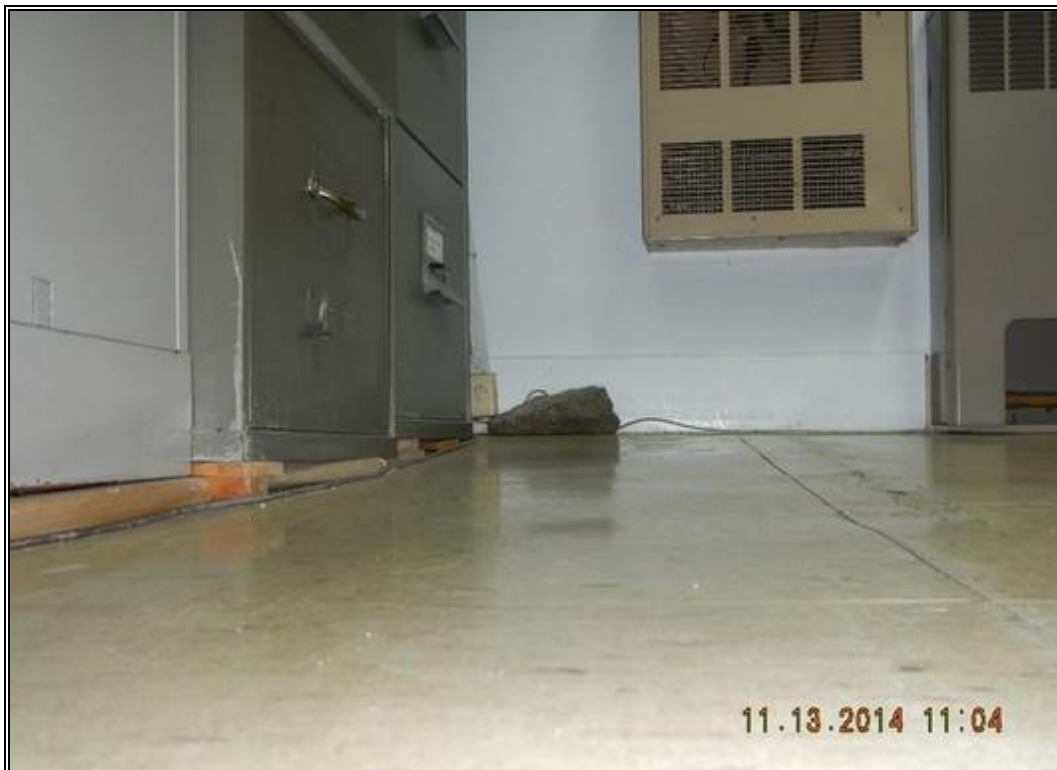
Photo Number
20

Description:
Floor surface
below file cabinets
at front left

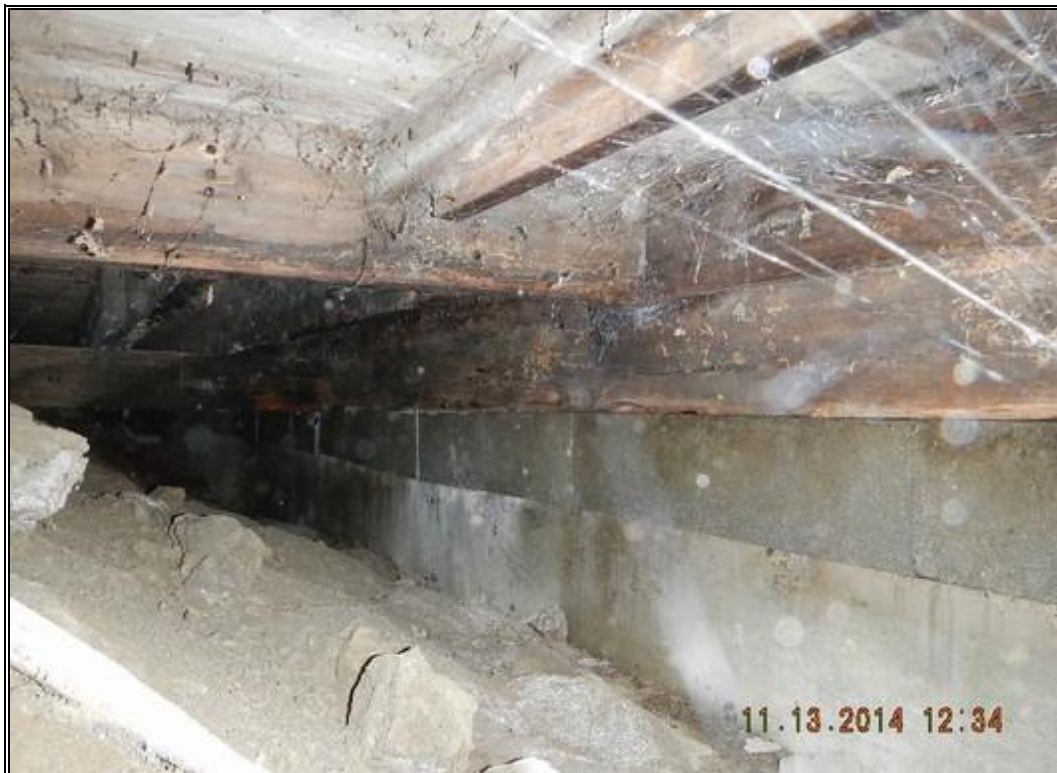
Photo Number
21

Description:
Rot at back sill

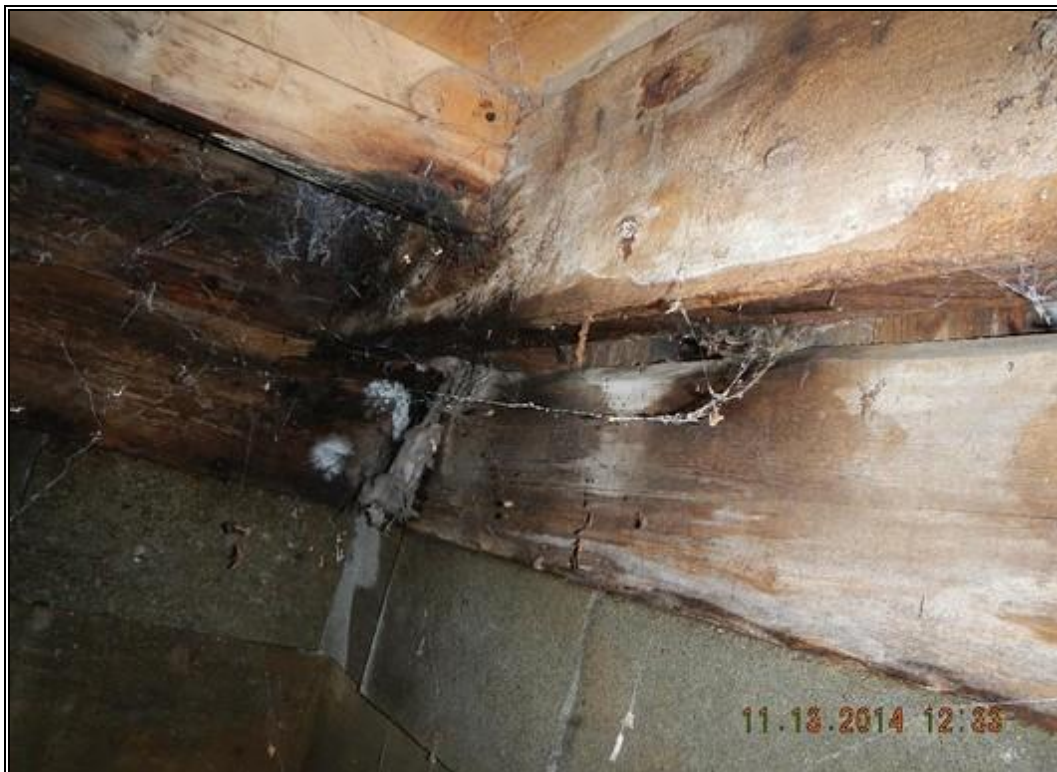
Photo Number
22

Description:
Rot at back sill

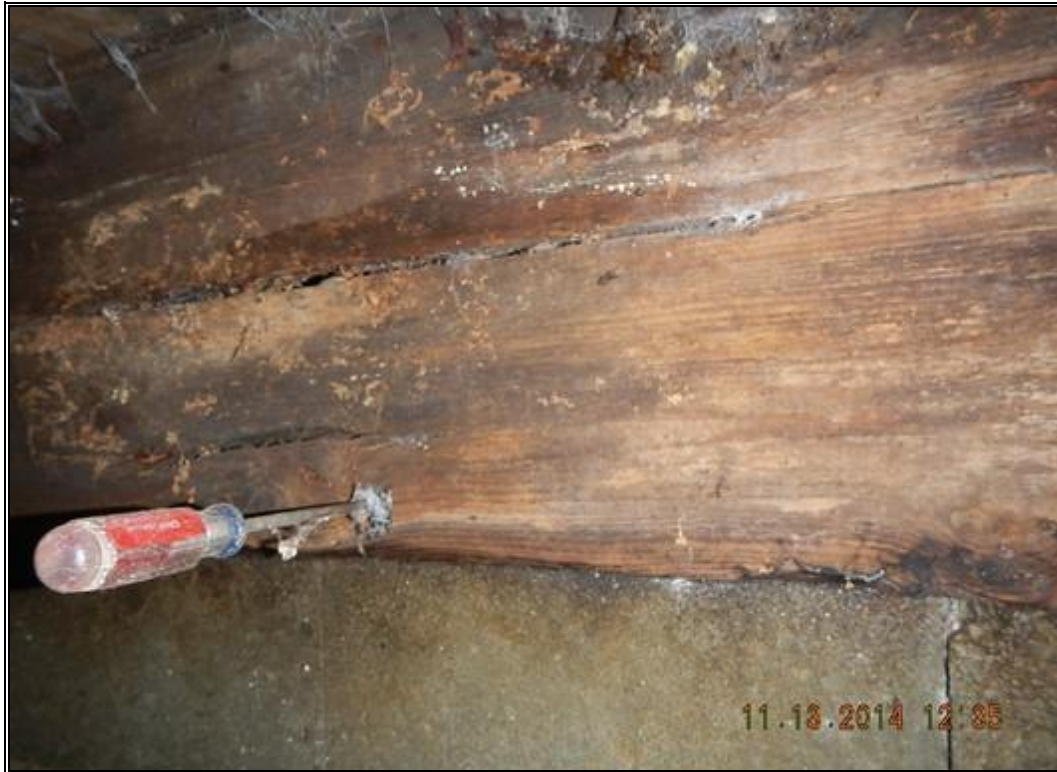
Photo Number
23

Description:
Rot at back sill

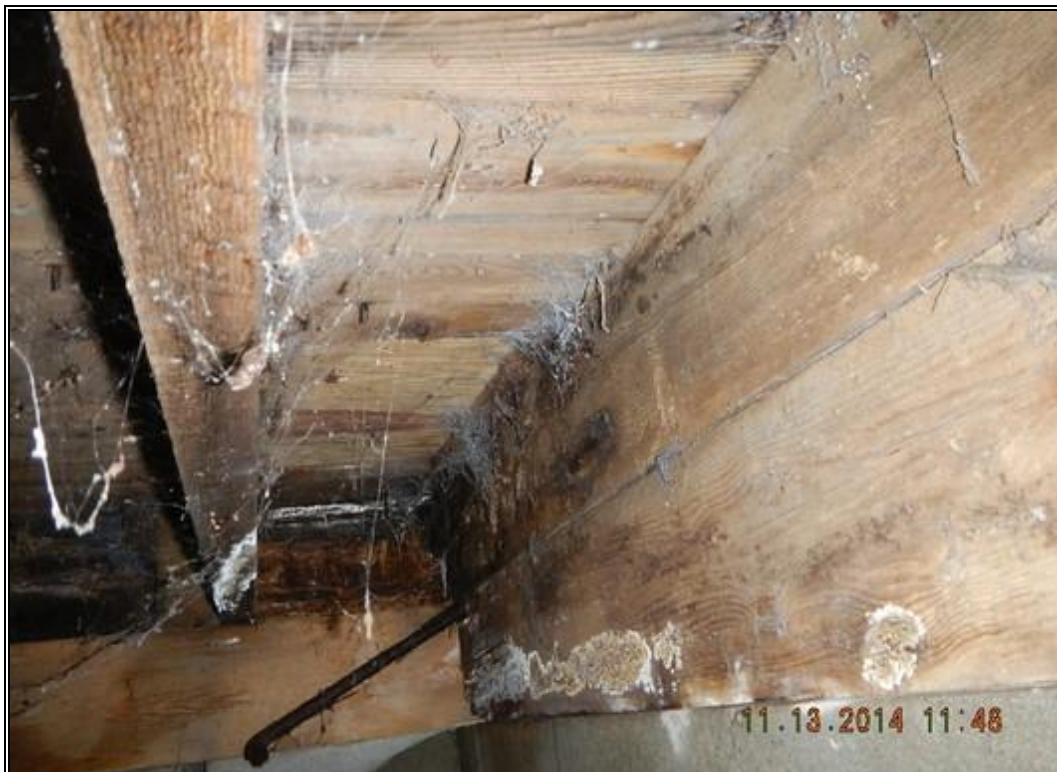
Photo Number
24

Description:
Rotted rim joist
and floor joists,
back left

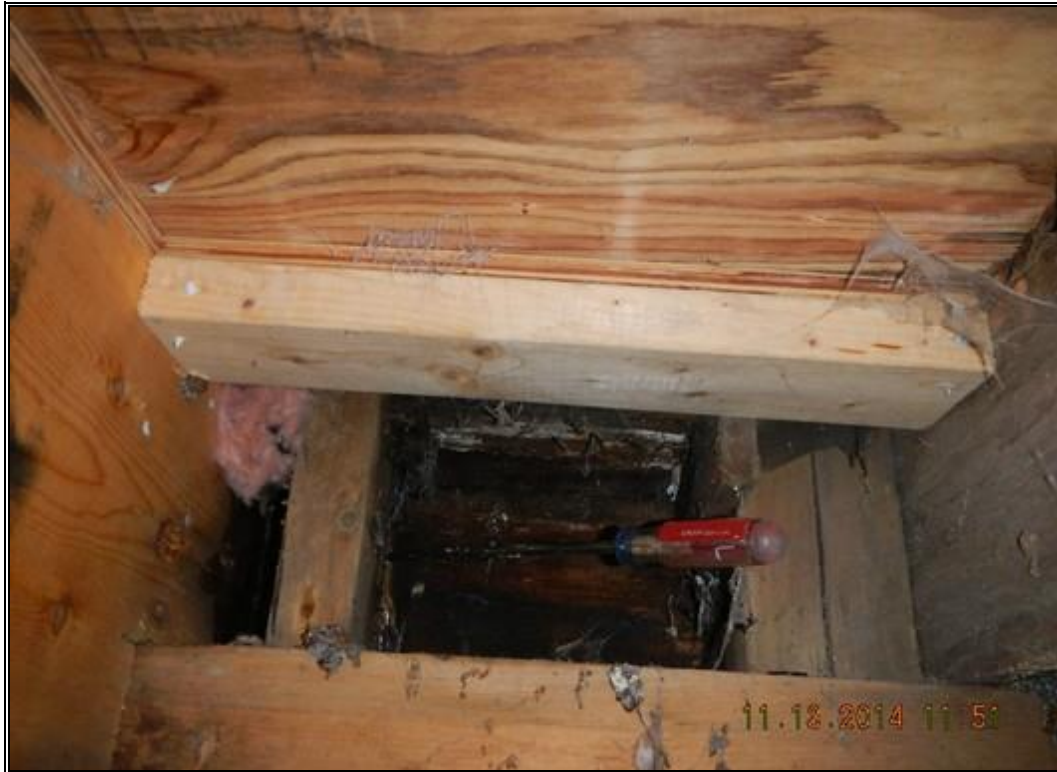
Photo Number
25

Description:
Rotted band joist,
back left

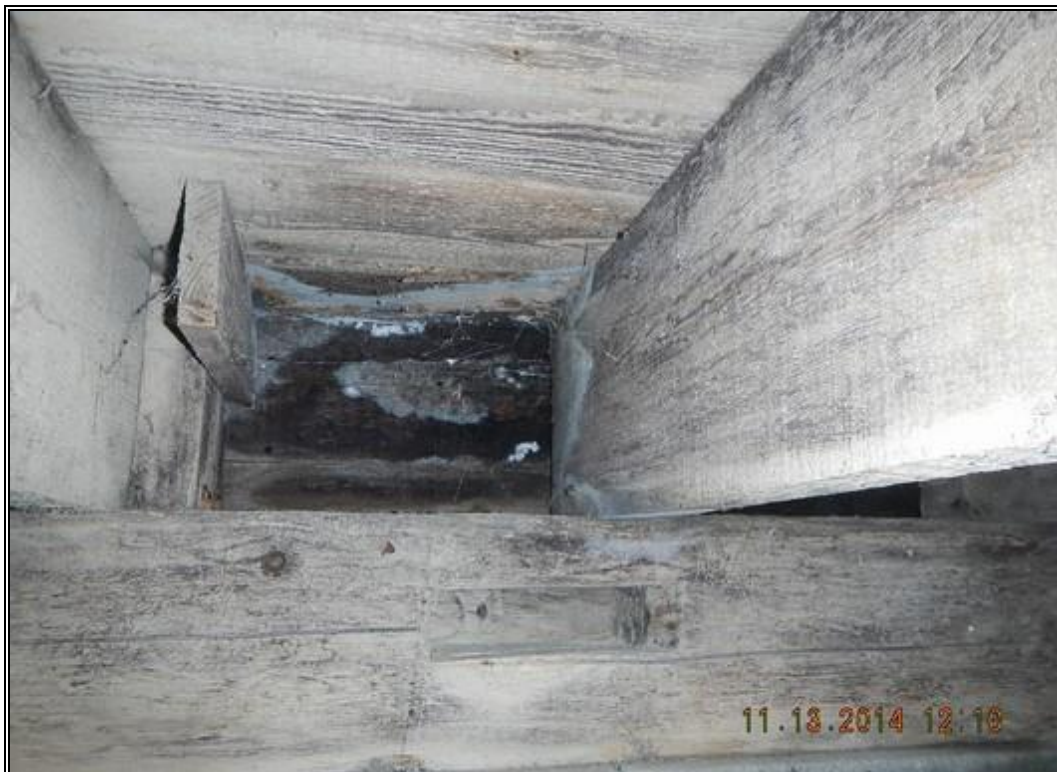
Photo Number
26

Description:
Rotted rim joist

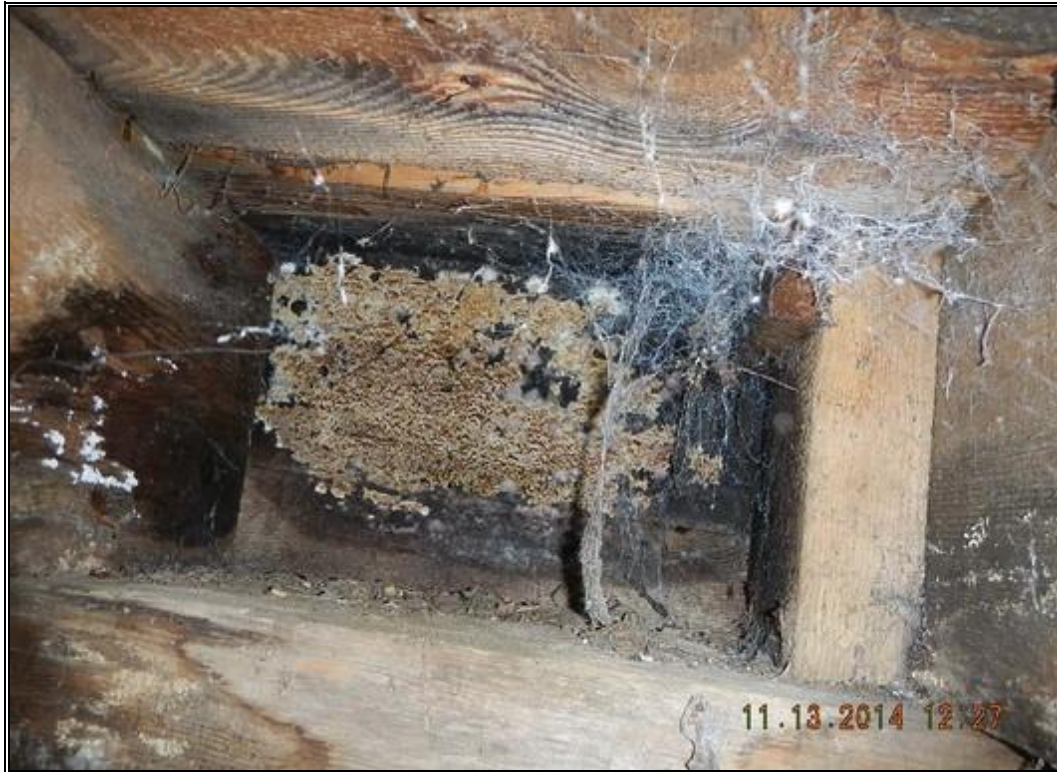
Photo Number
27

Description:
Mold on rotted rim
joist, back right

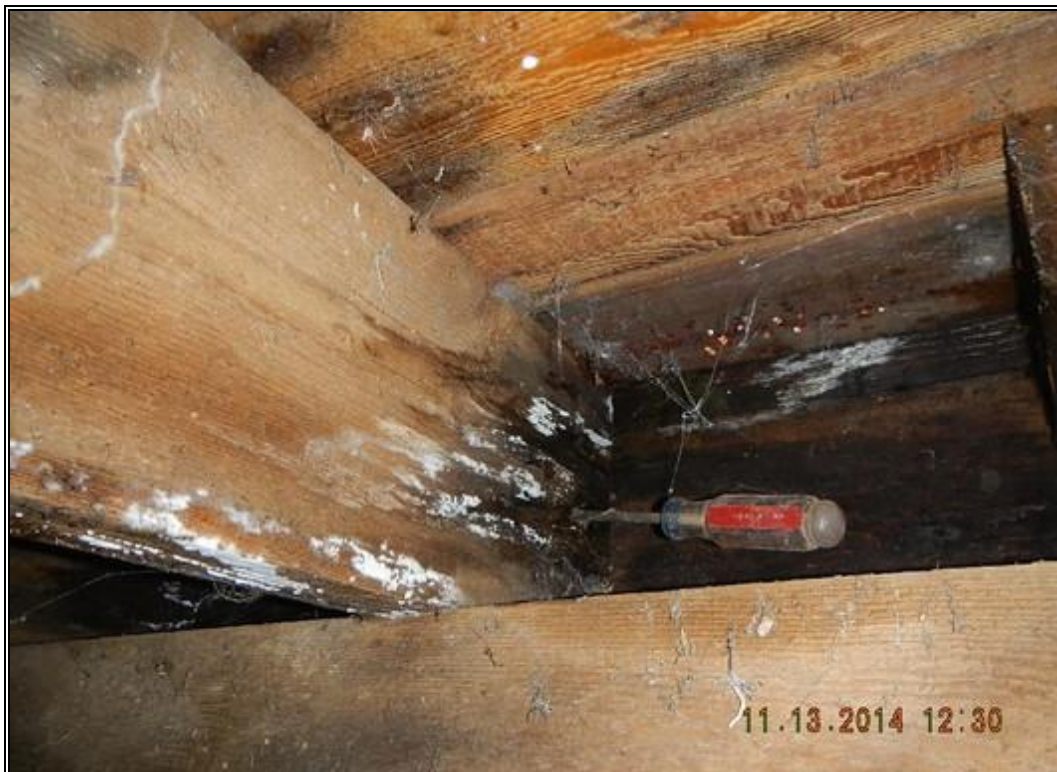
Photo Number
28

Description:
Rotted rim joist
and floor joist,
back right
