Location:
Addison Town Hall
Addison, Maine

Photo Taken by:
Keith R Brown, P.E.

Date:
Nov. 13, 2014

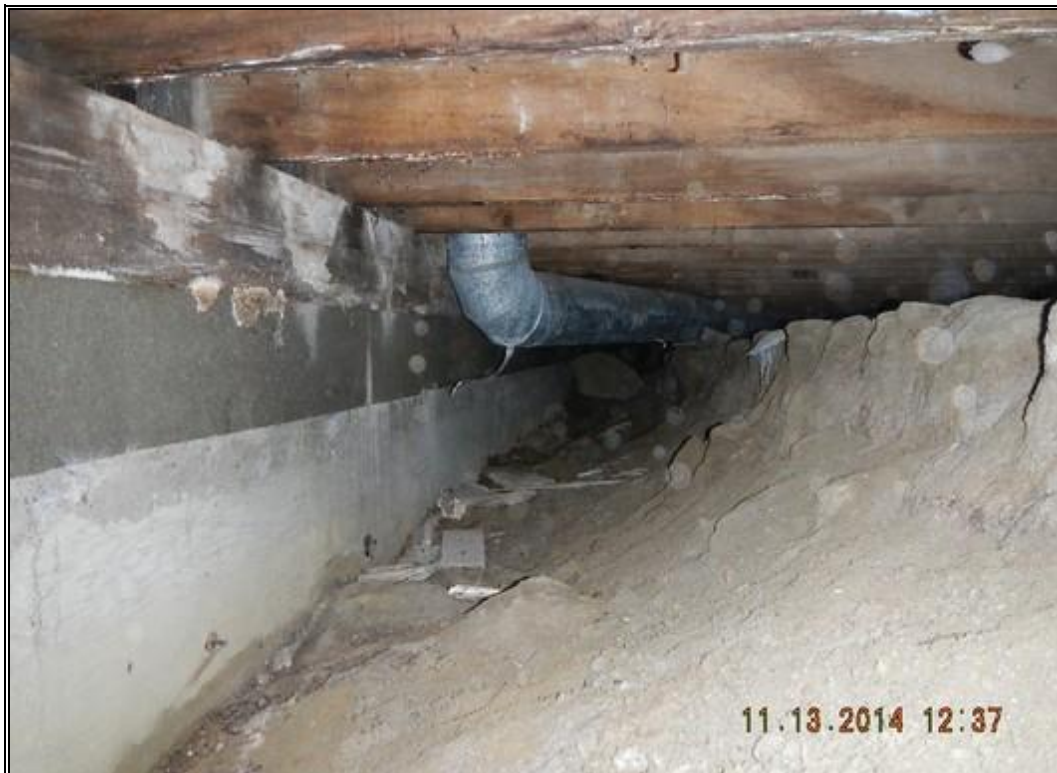
Photo Number
29

Description:
Mold growth and deterioration at along back portion of right side wall

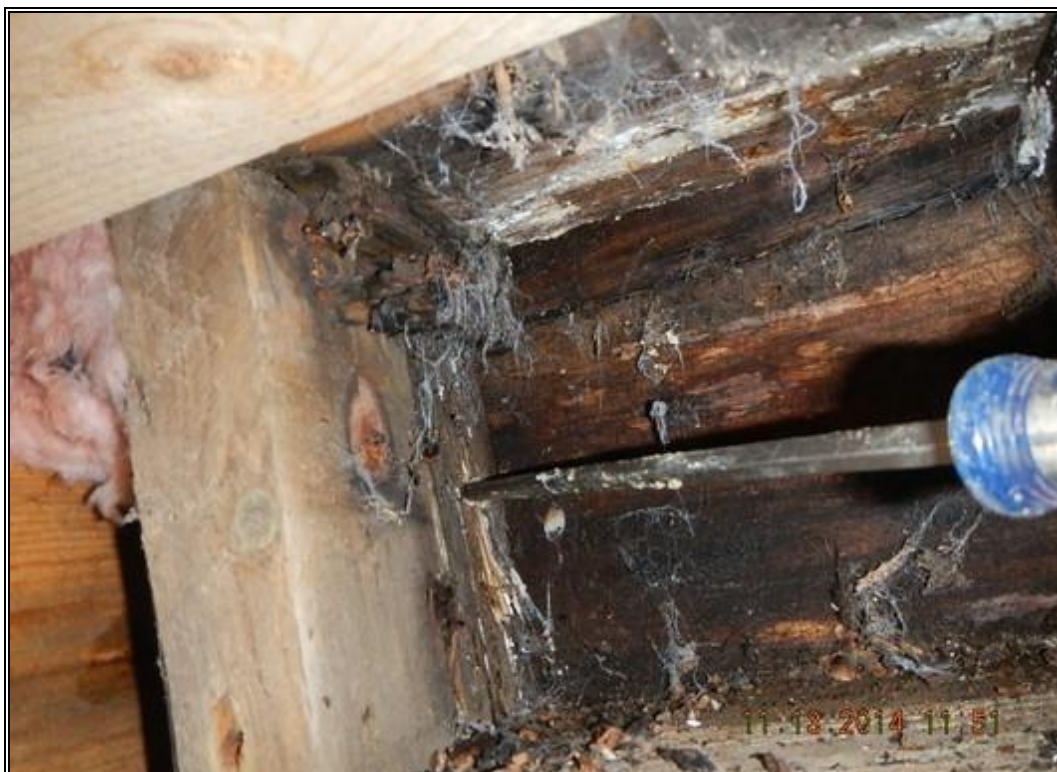
Photo Number
30

Description:
Rotted stud at back right of building

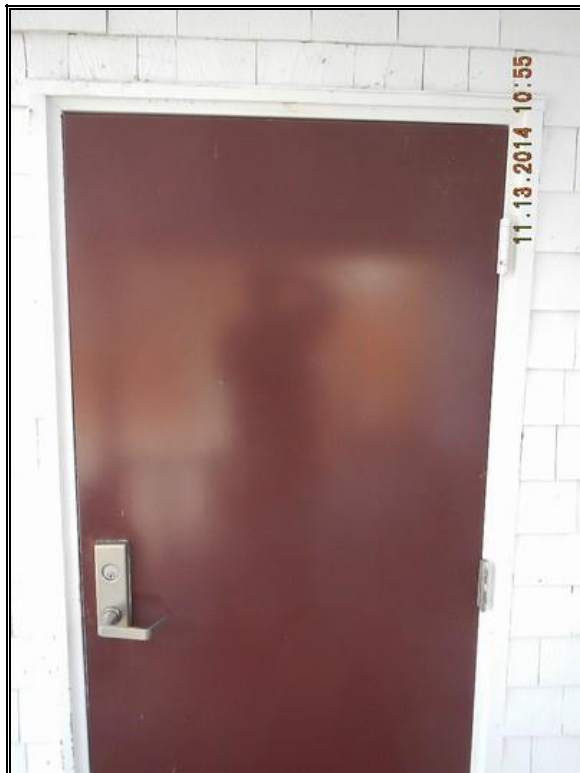
Photo Number
33

Description:
Back exterior door

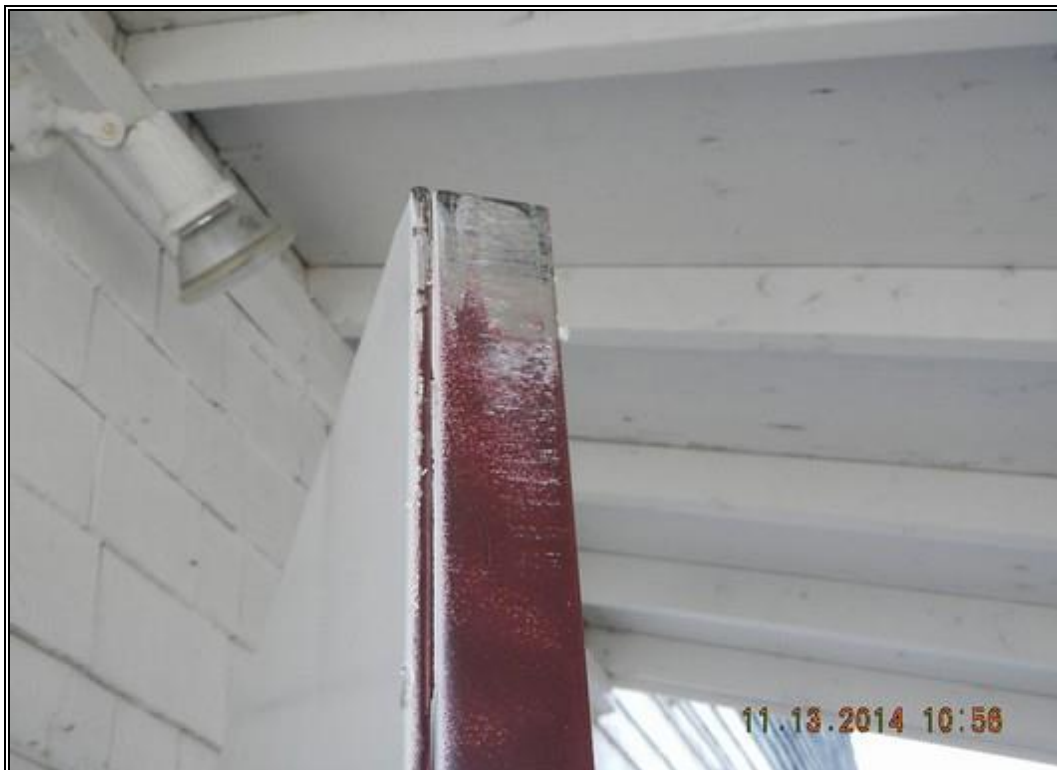
Photo Number
34

Description:
Abraded paint at
location where
door rubs frame

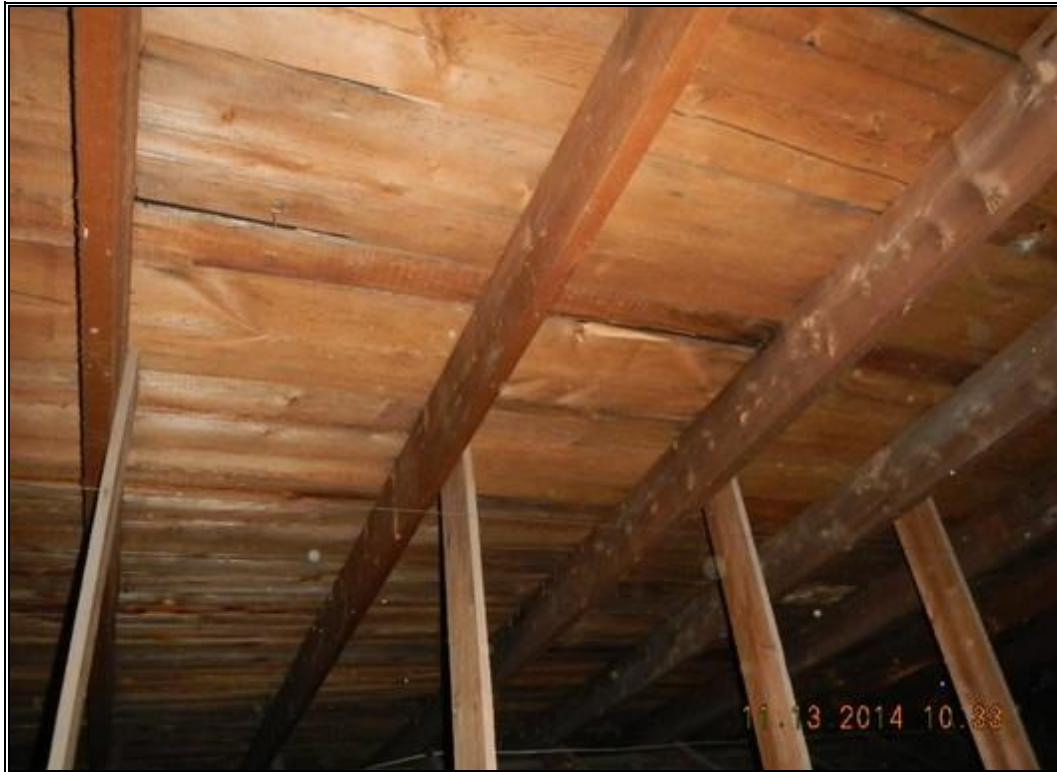
Photo Number
35

Description:
Roof framing

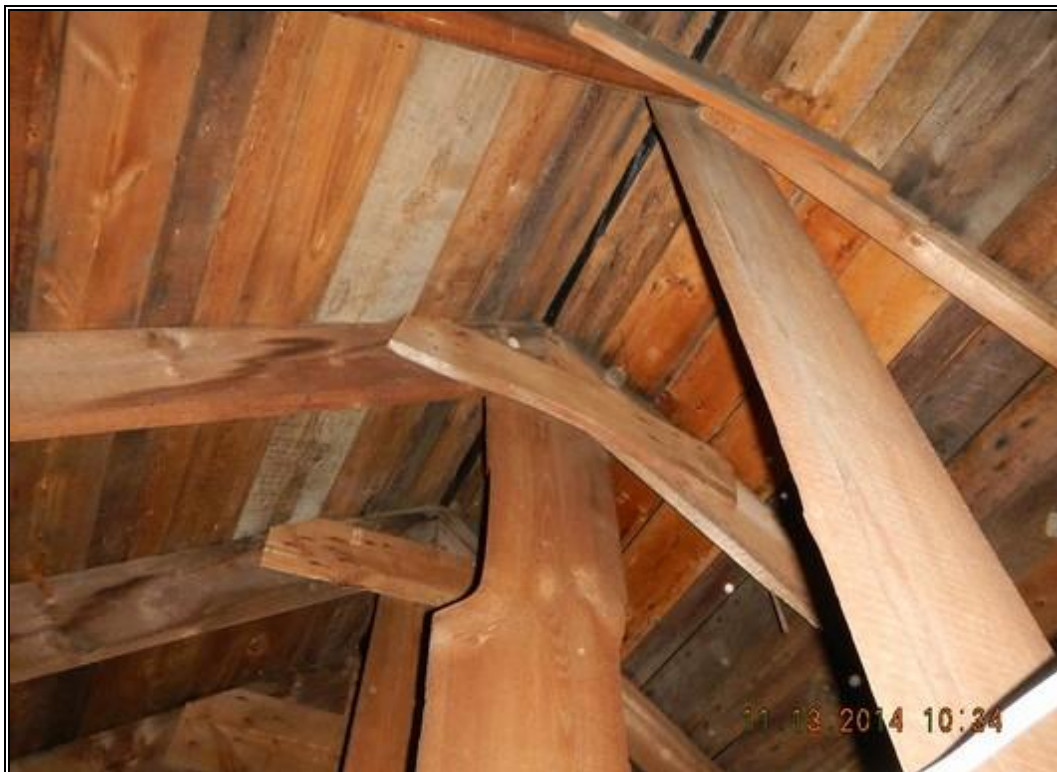
Photo Number
36

Description:
Roof framing

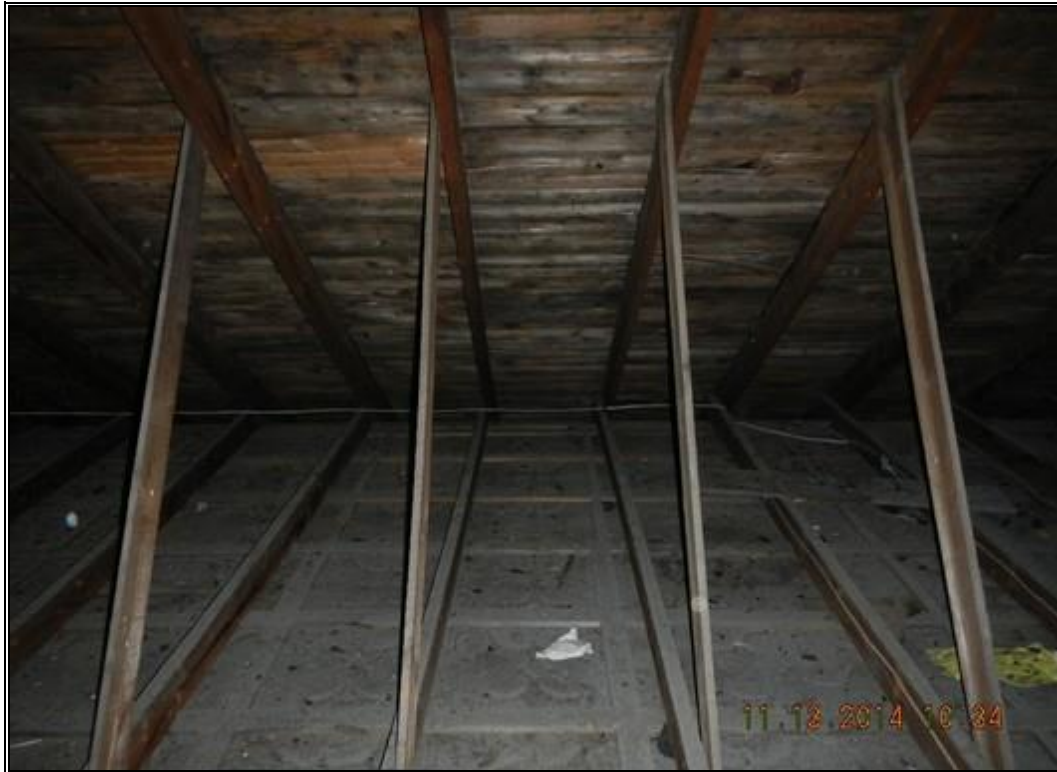
Photo Number
37

Description:
Roof framing

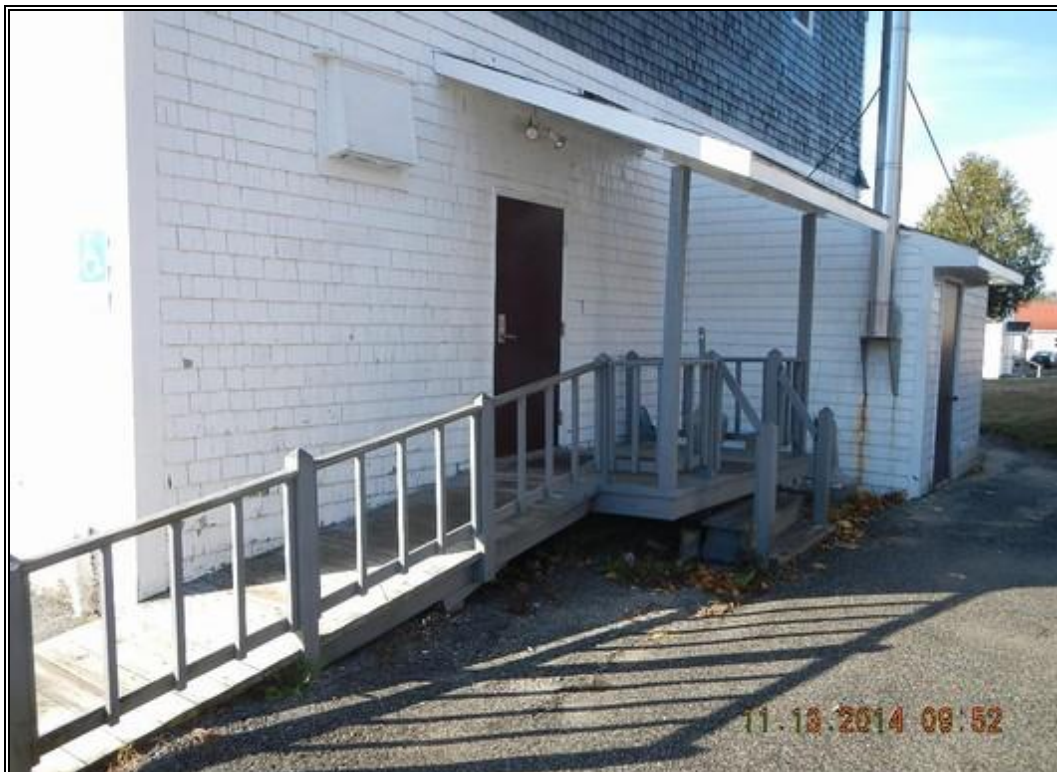
Photo Number
38

Description:
Back entrance
ramp and canopy

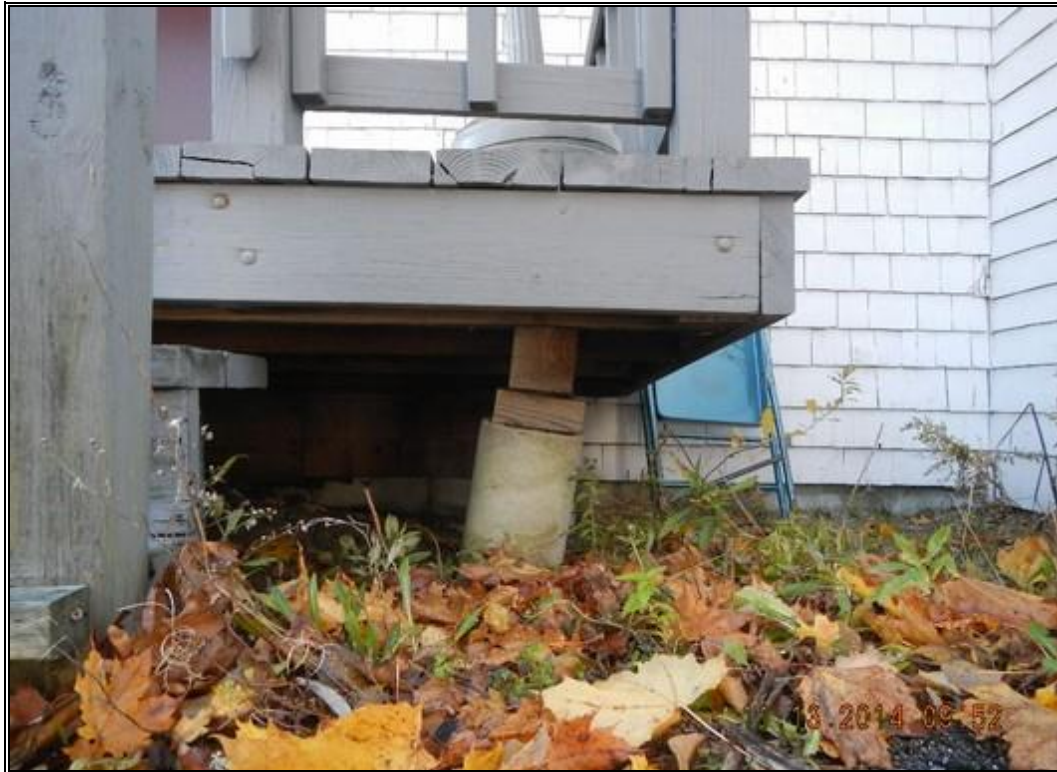
Photo Number
39

Description:
Support pier at
back entrance

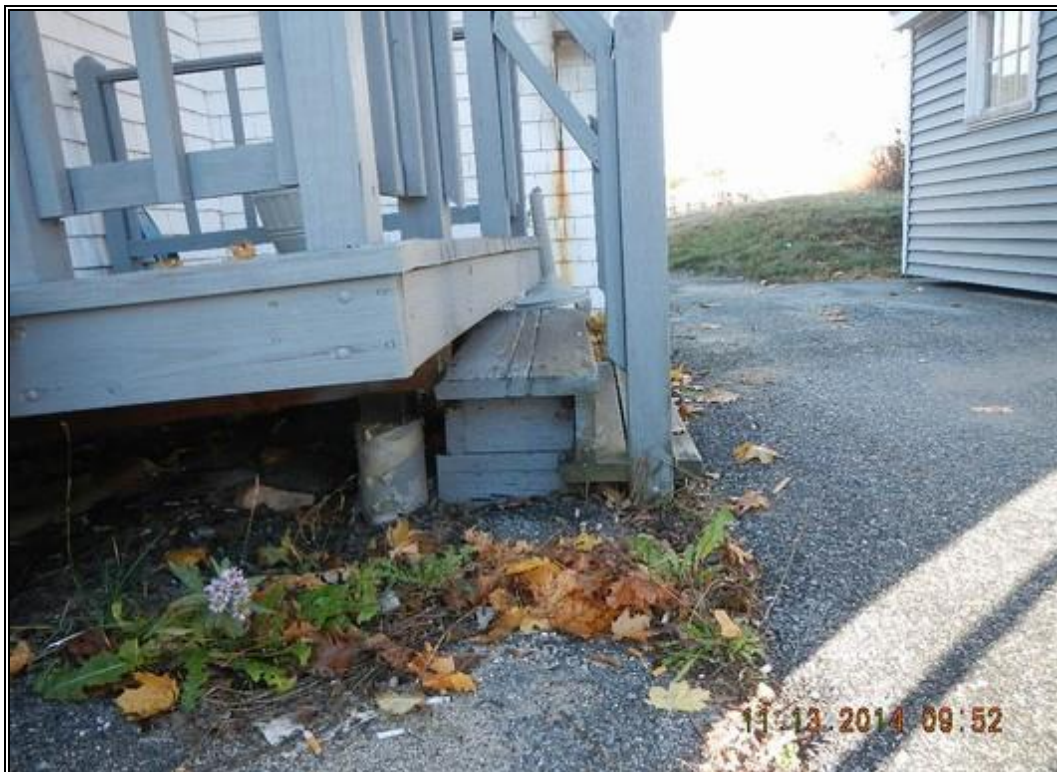
Photo Number
40

Description:
Steps at back
entrance

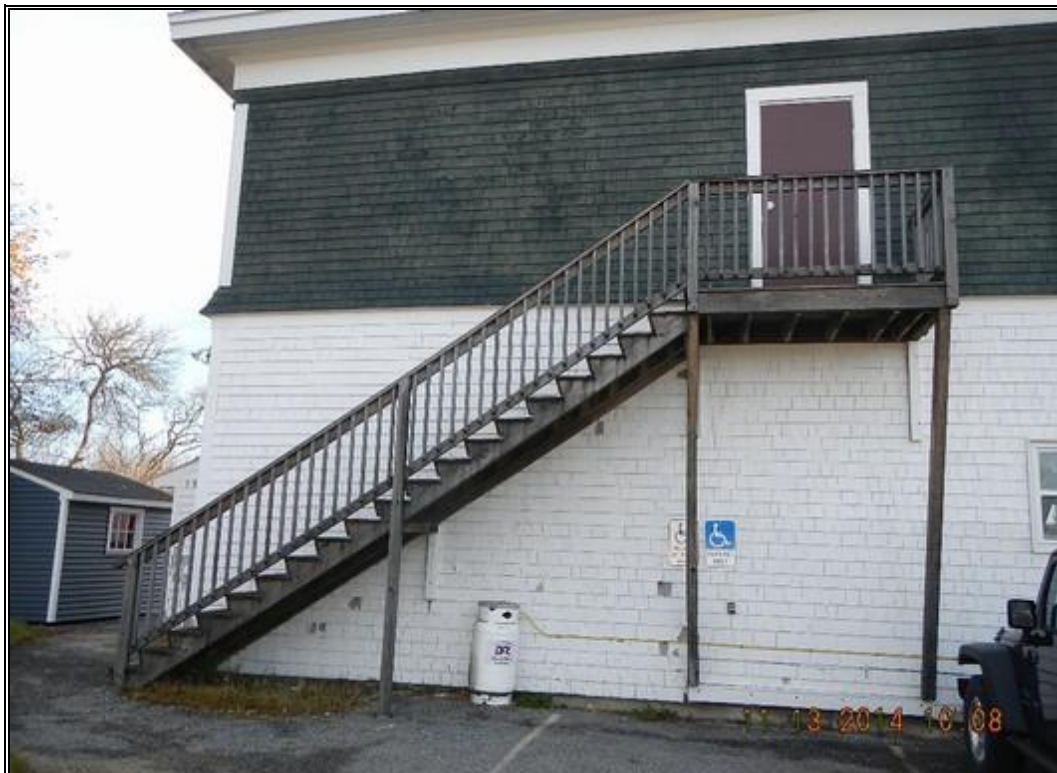
Photo Number
41

Description:
Second floor
egress staircase
and landing

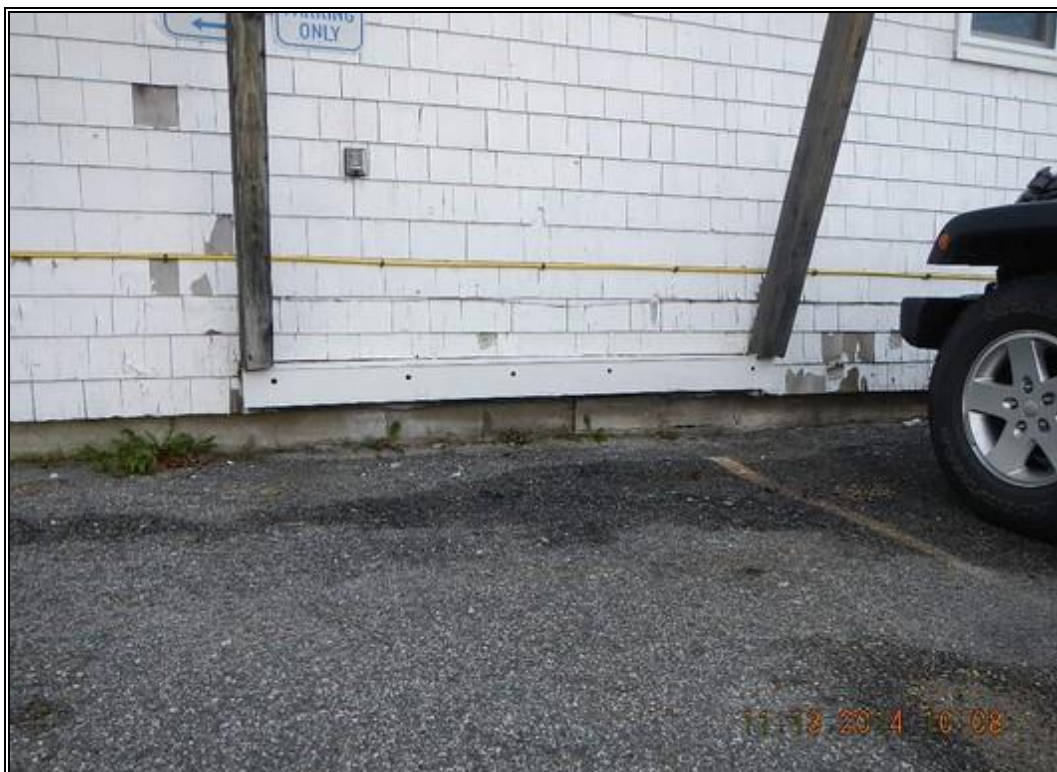
Photo Number
42

Description:
Angle support
braces at second
floor egress
staircase and
landing

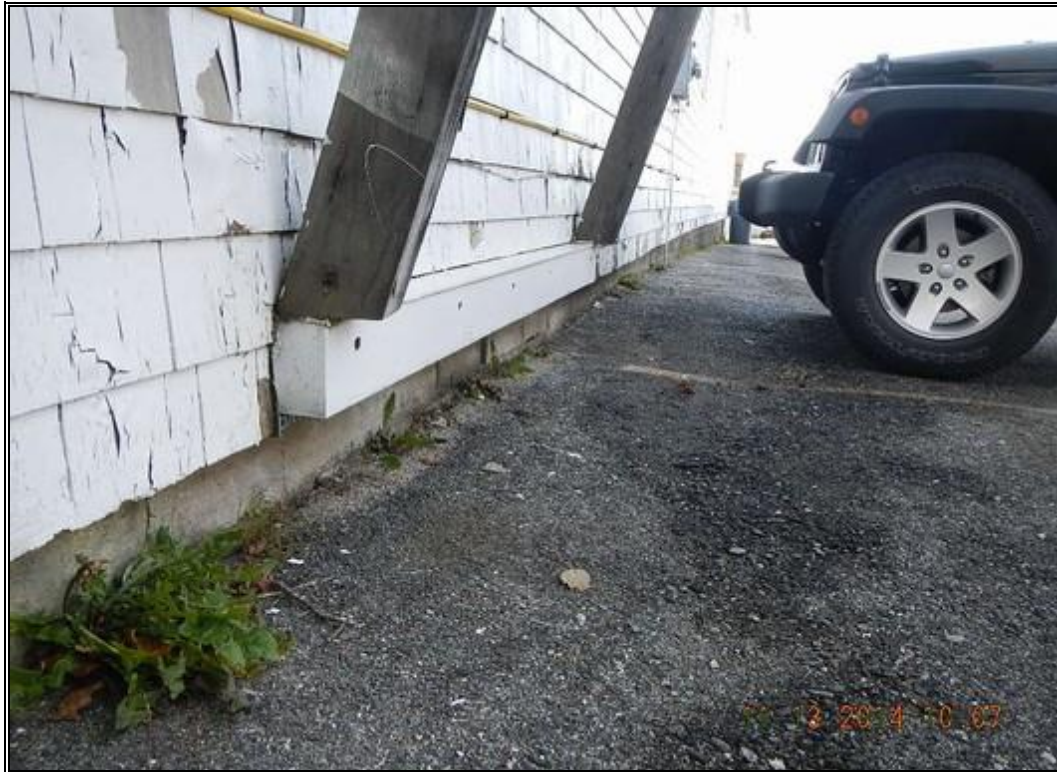
Photo Number
43

Description:
Support ledger at
right side staircase
and landing

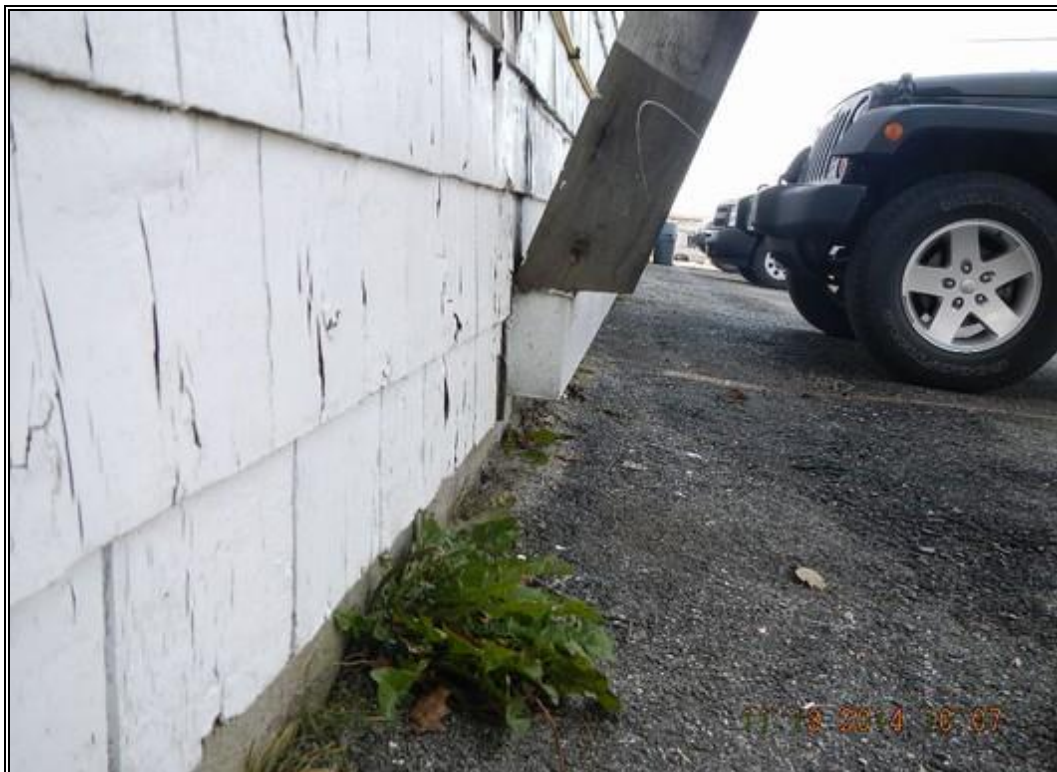
Photo Number
44

Description:
Support ledger at
right side staircase
and landing
