Location:
Addison Town Hall
Addison, Maine

Photo Taken by:
Keith R Brown, P.E.

Date:
Feb. 6, 2015

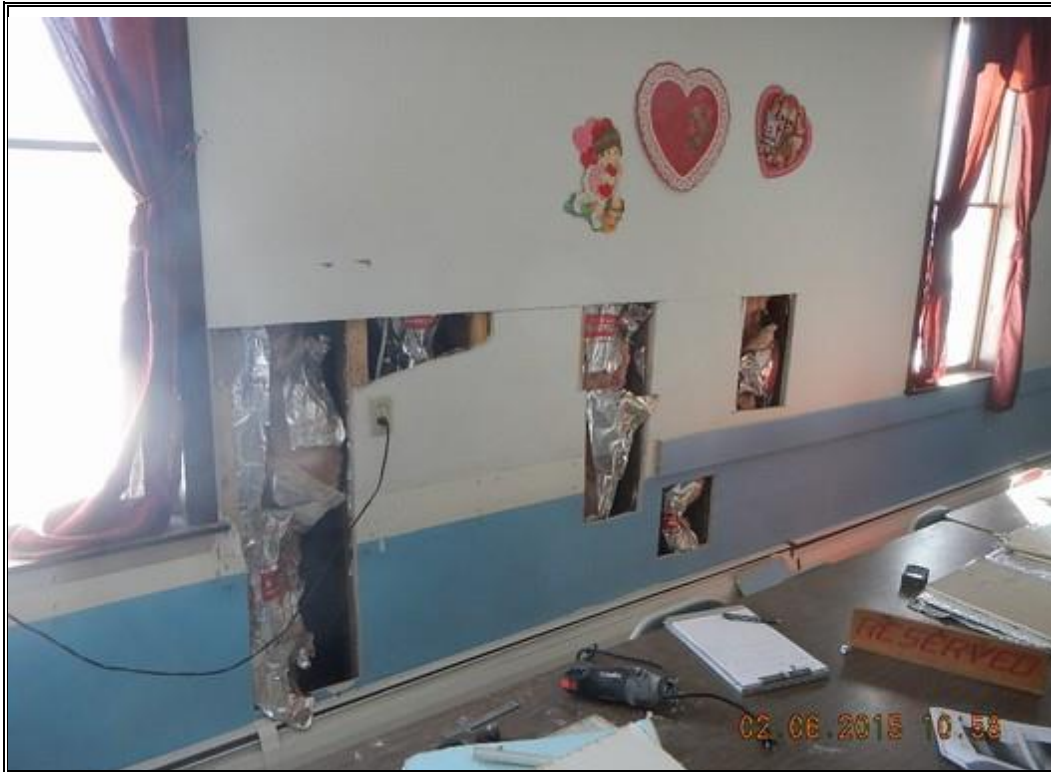
Photo Number
46

Description:
Openings created
for invasive
inspection

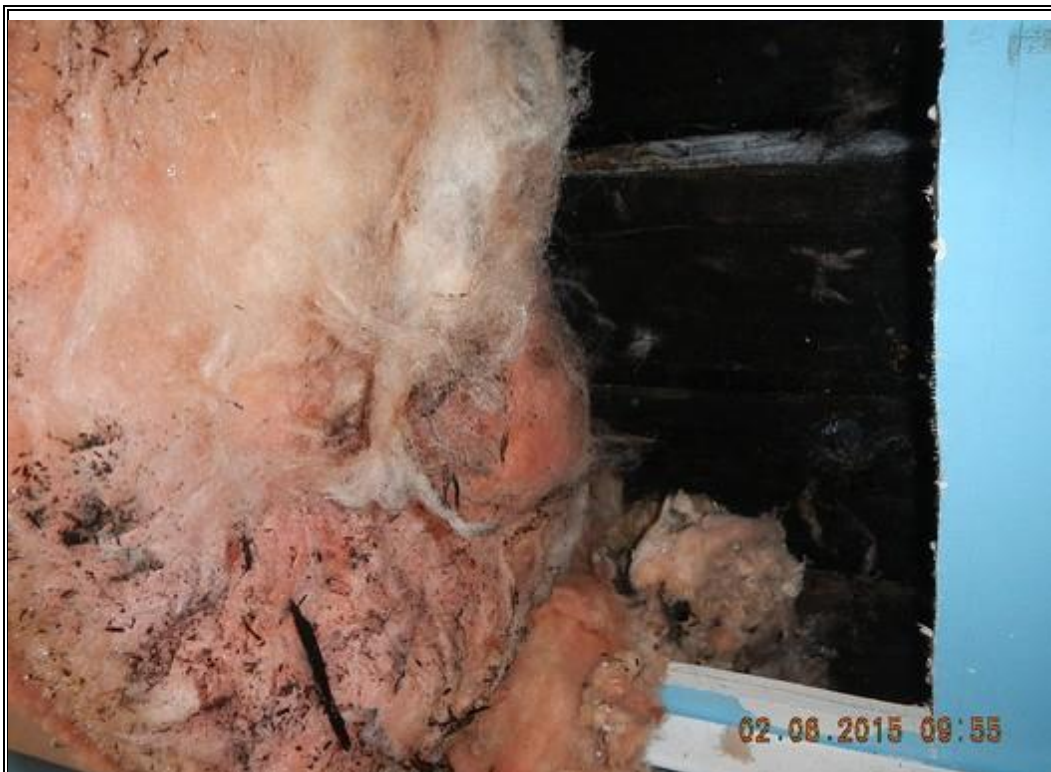
Photo Number
47

Description:
Wet insulation and
rotted siding

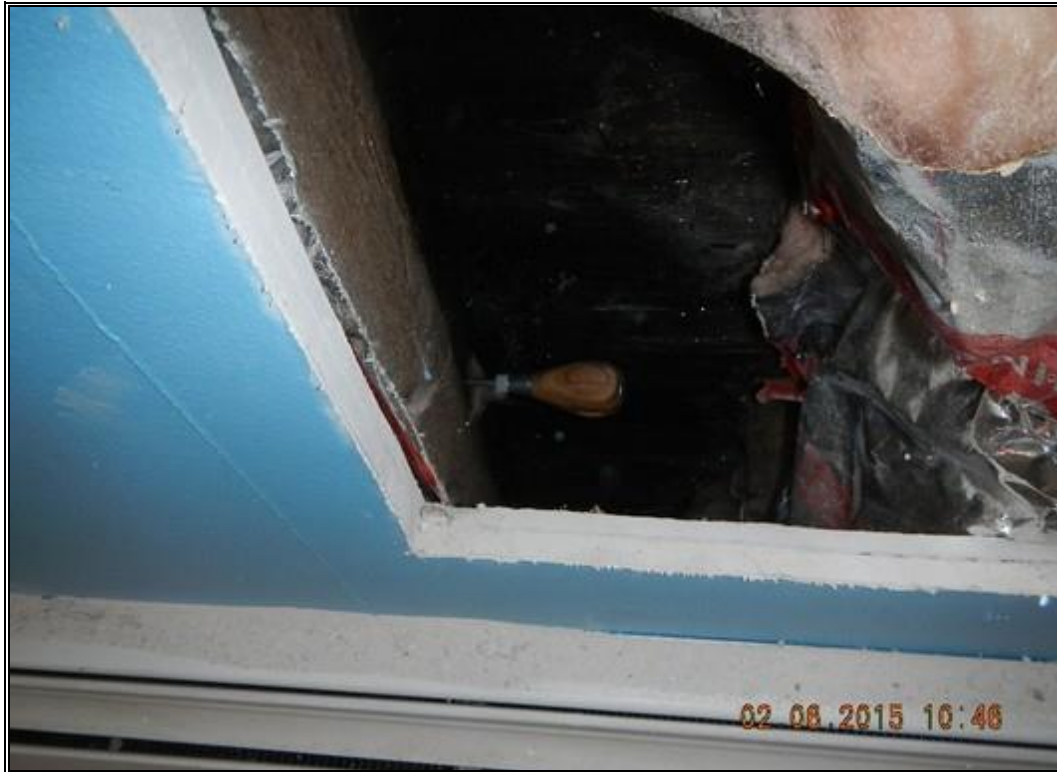
Photo Number
48

Description:
Rot damage on
stud and wall
sheathing

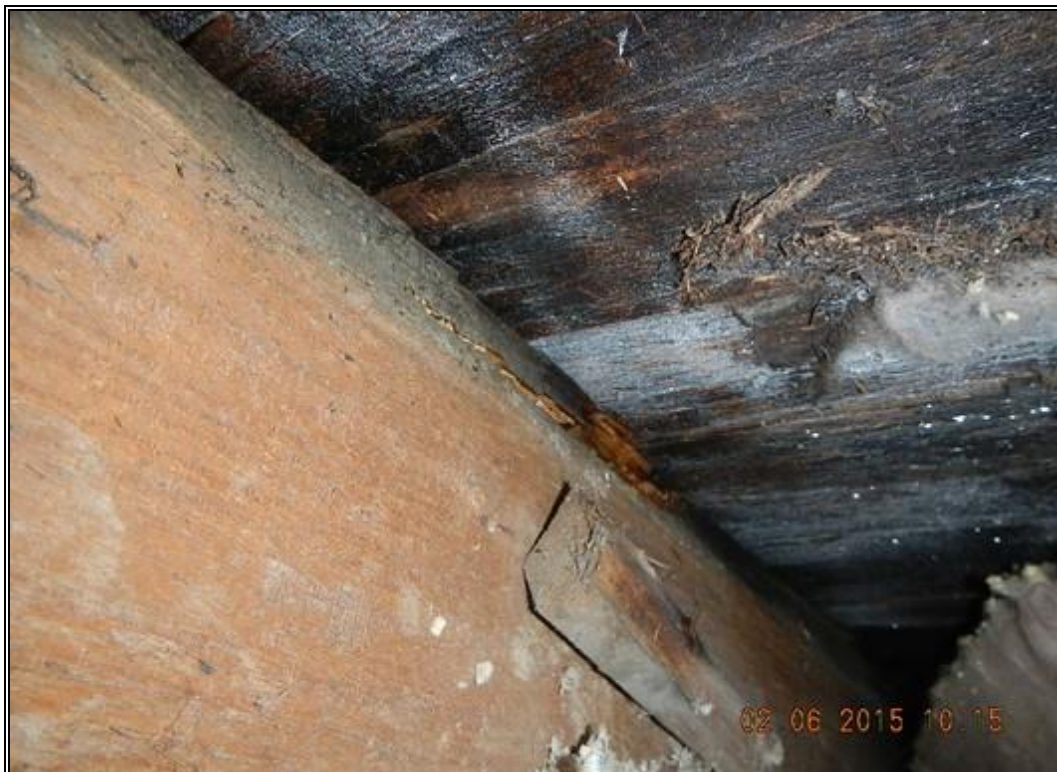
Photo Number
49

Description:
Rot damage on
stud and wall
sheathing

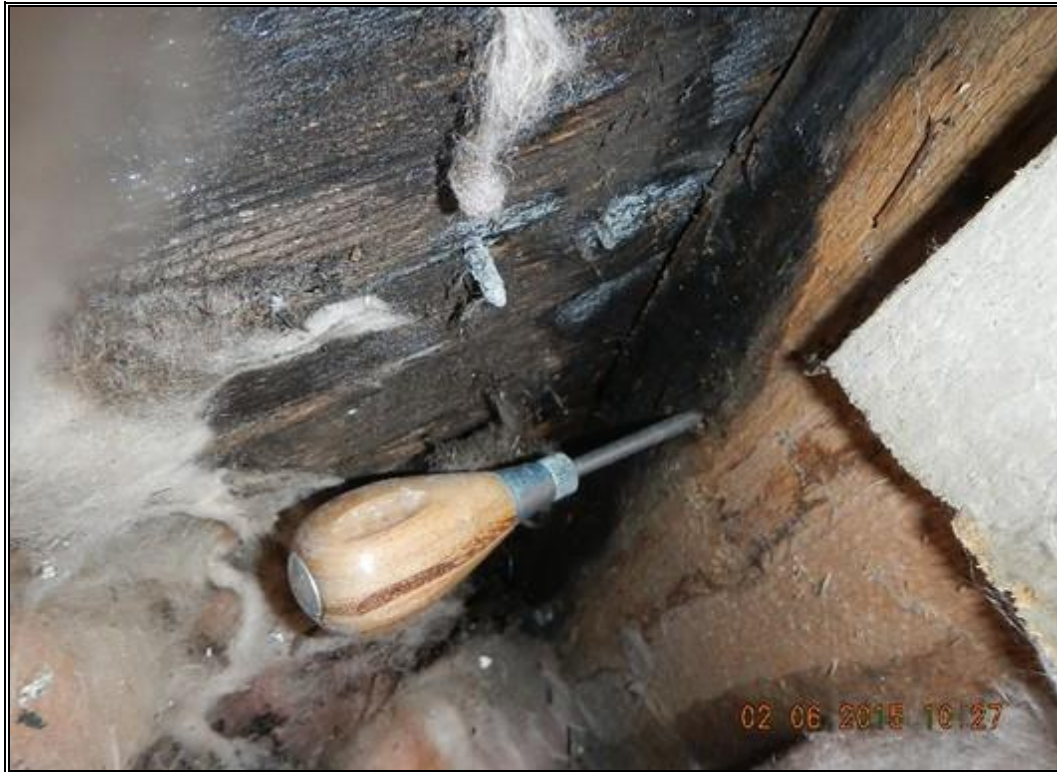
Photo Number
50

Description:
Rot damage on
stud and wall
sheathing

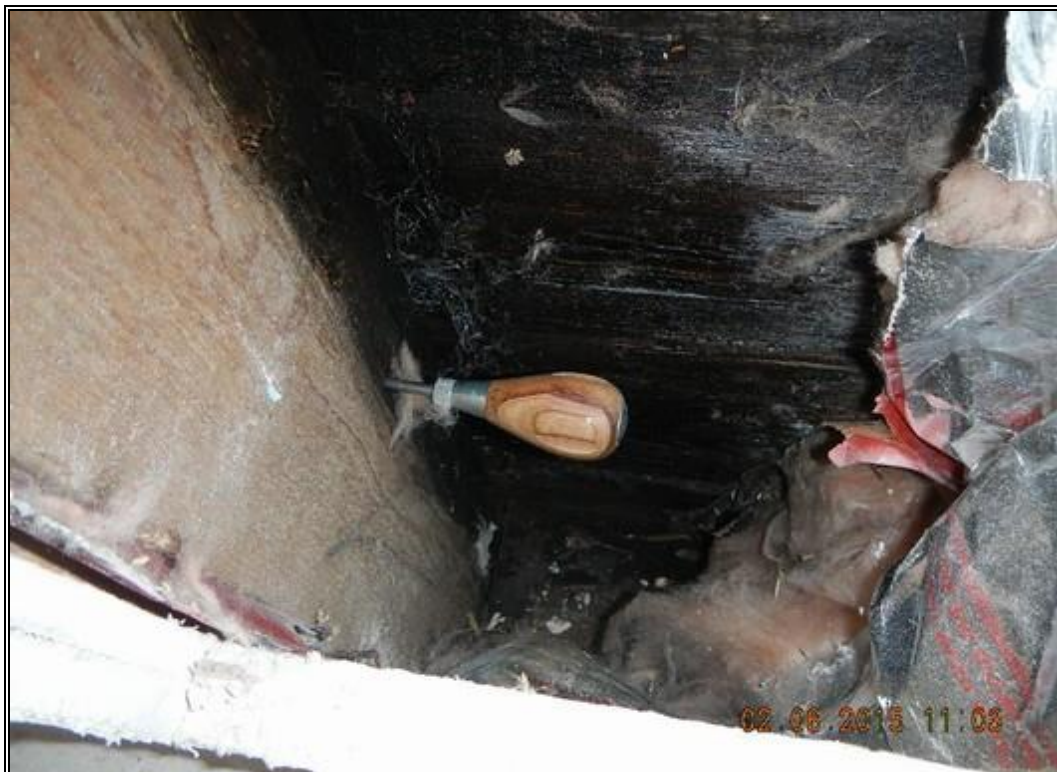
Photo Number
51

Description:
Rotted stud and
wall sheathing 80
inches from front
of right rear
window

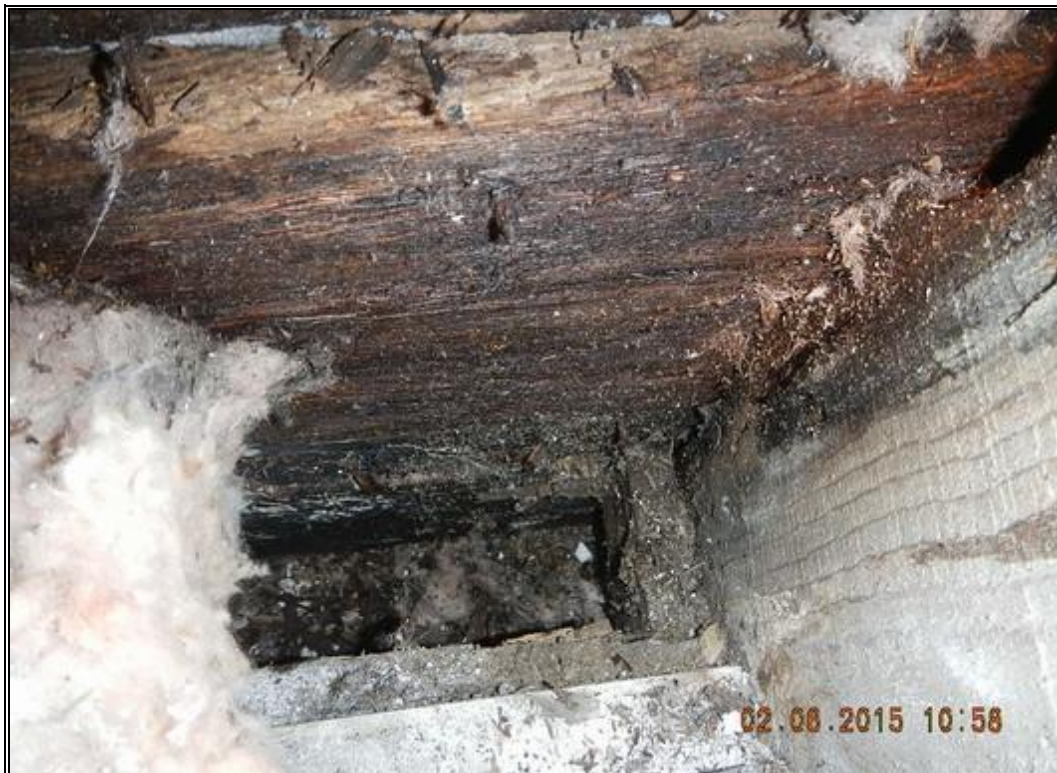
Photo Number
52

Description:
Rotted stud, sill framing and wall sheathing (note that fire stop has disintegrated entirely)

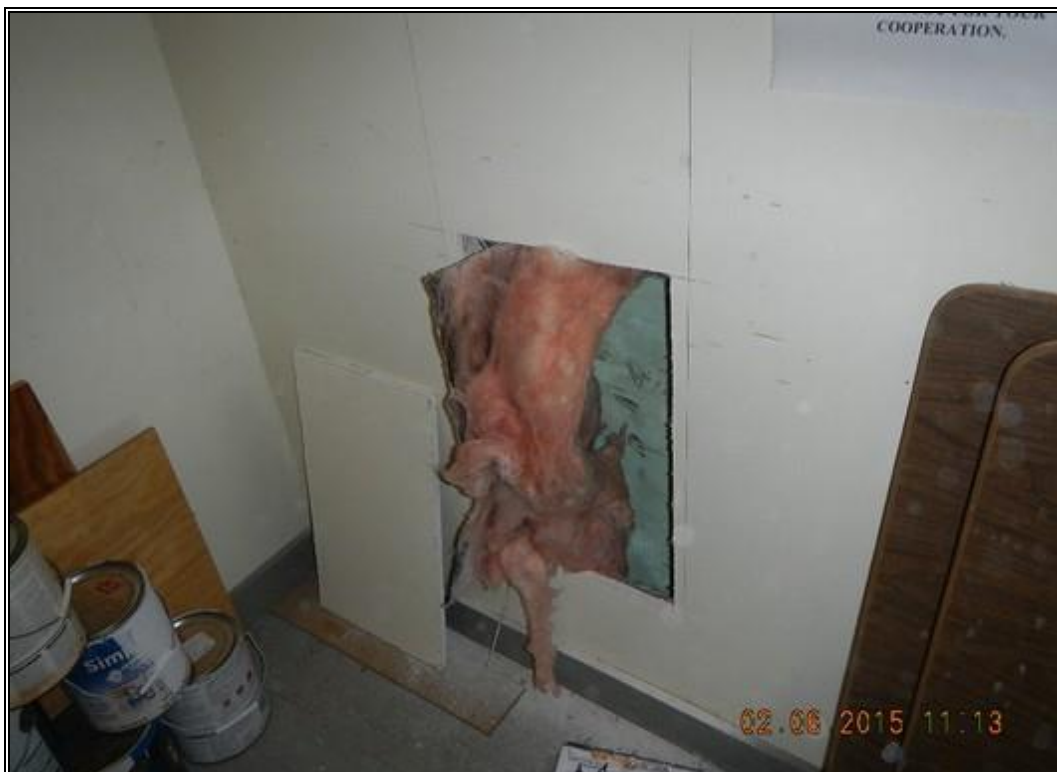
Photo Number
53

Description:
Wall opening in front right stairwell

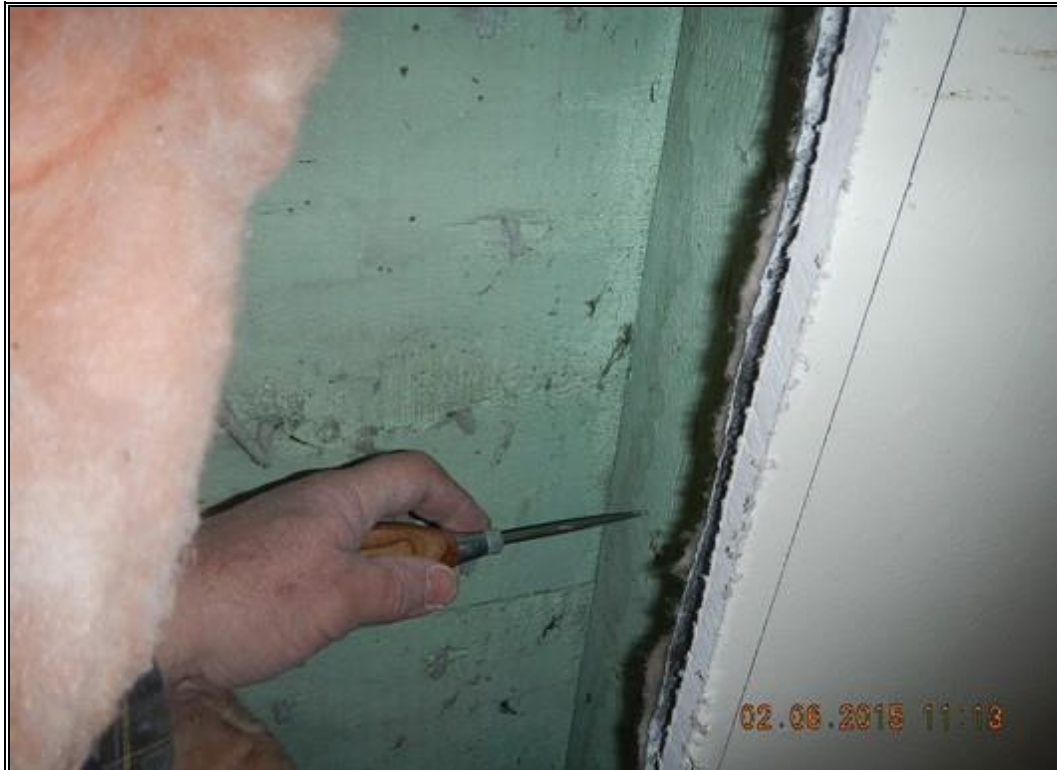
Photo Number
54

Description:
Stud and wall
sheathing in front
right stairwell

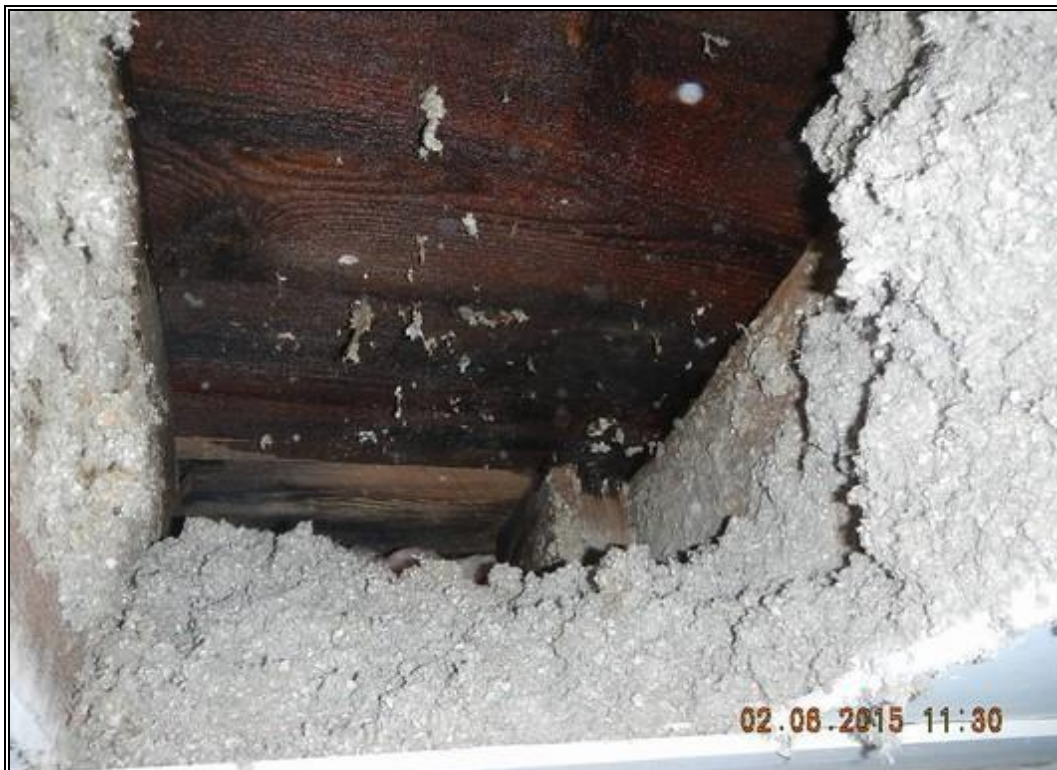
Photo Number
55

Description:
Second floor joist,
second floor deck
above right side
wall

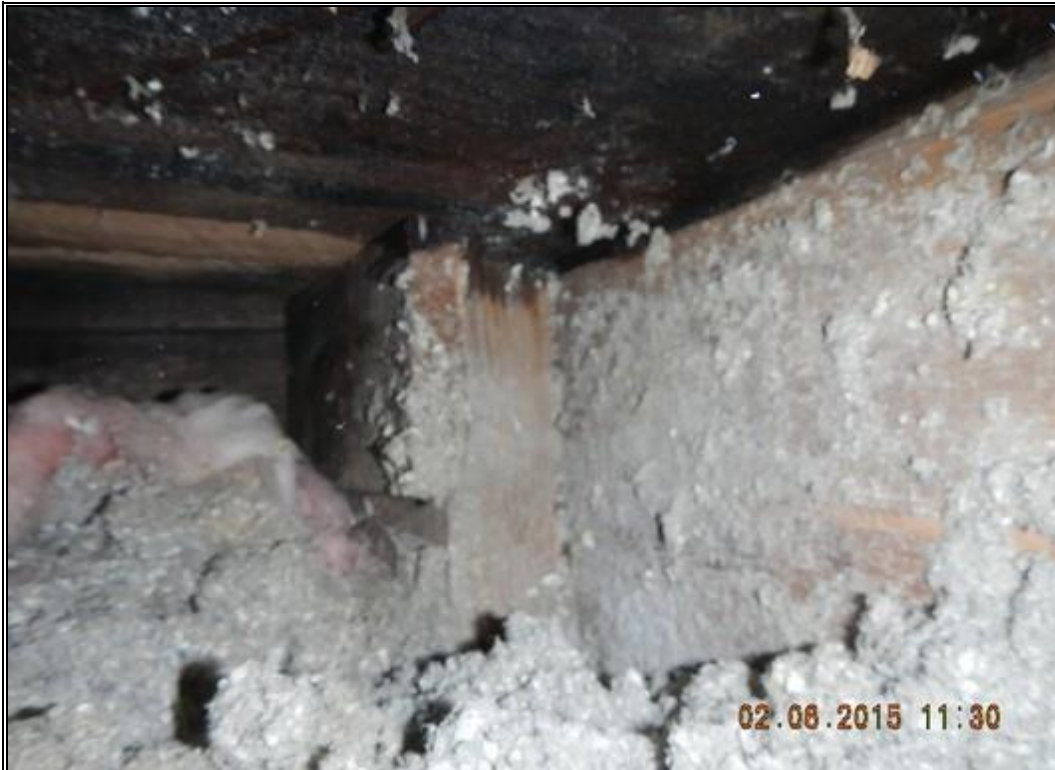
56

Description:
Second floor joist-
to-stud connection

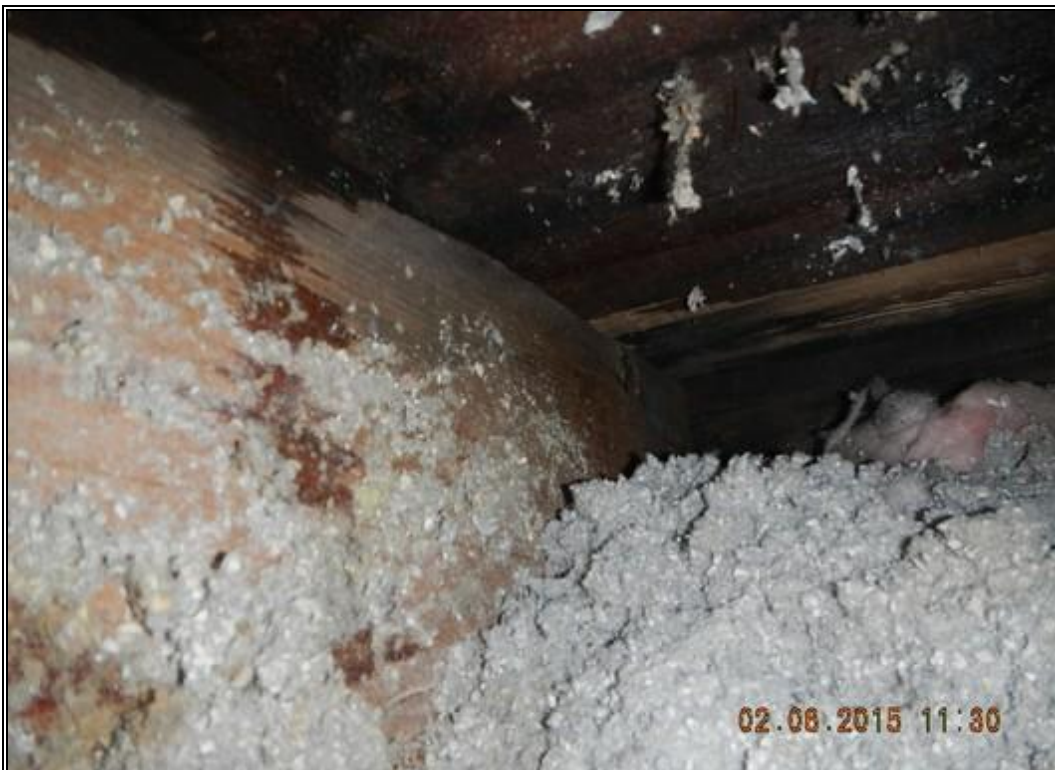
57

Description:
Second floor joist,
second floor deck
above right side
wall
